**South Central Connecticut Regional Water District
Representative Policy Board**

Application to the RPB for the approval of disposition of 95 Ives Street in Hamden

**Portion of HA 13
95 Ives Street, Hamden**

**Application to the Representative Policy Board (RPB)
From the Regional Water Authority**

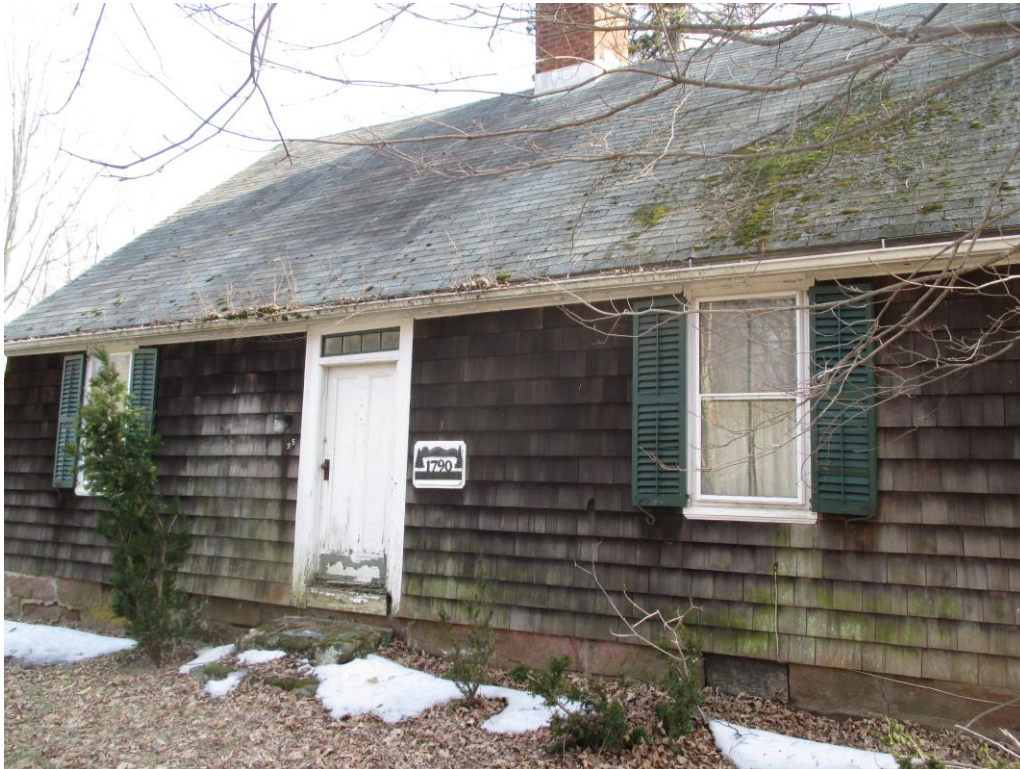
On-site house, photo taken 3/20/2019

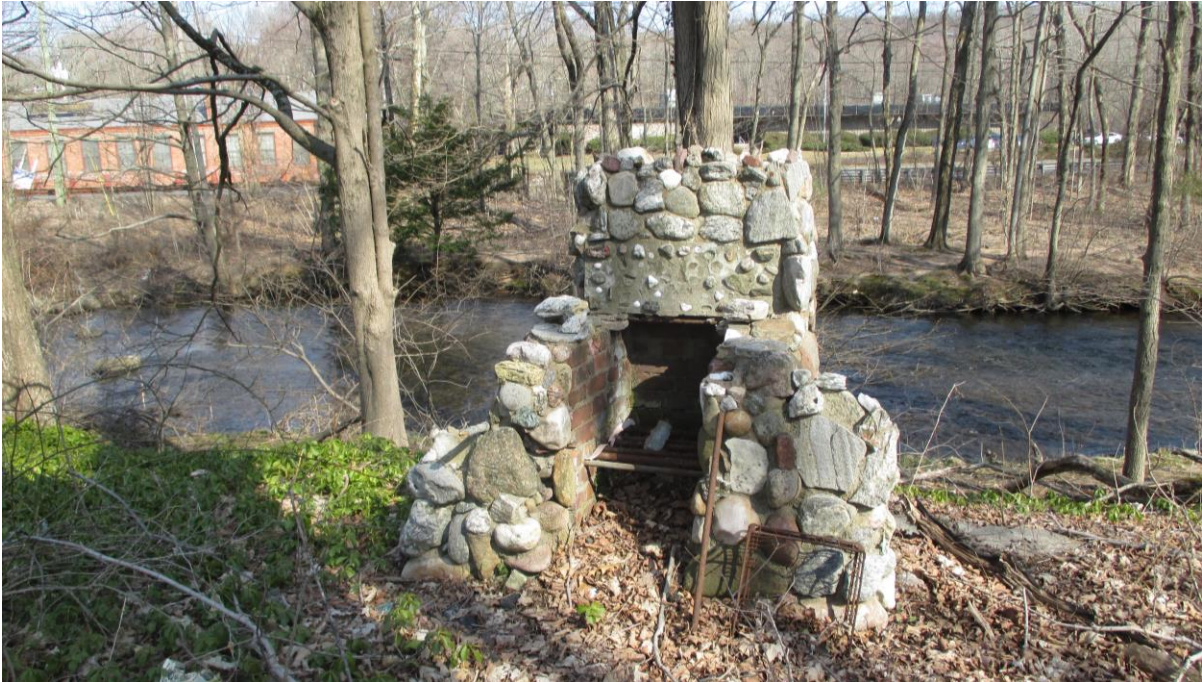
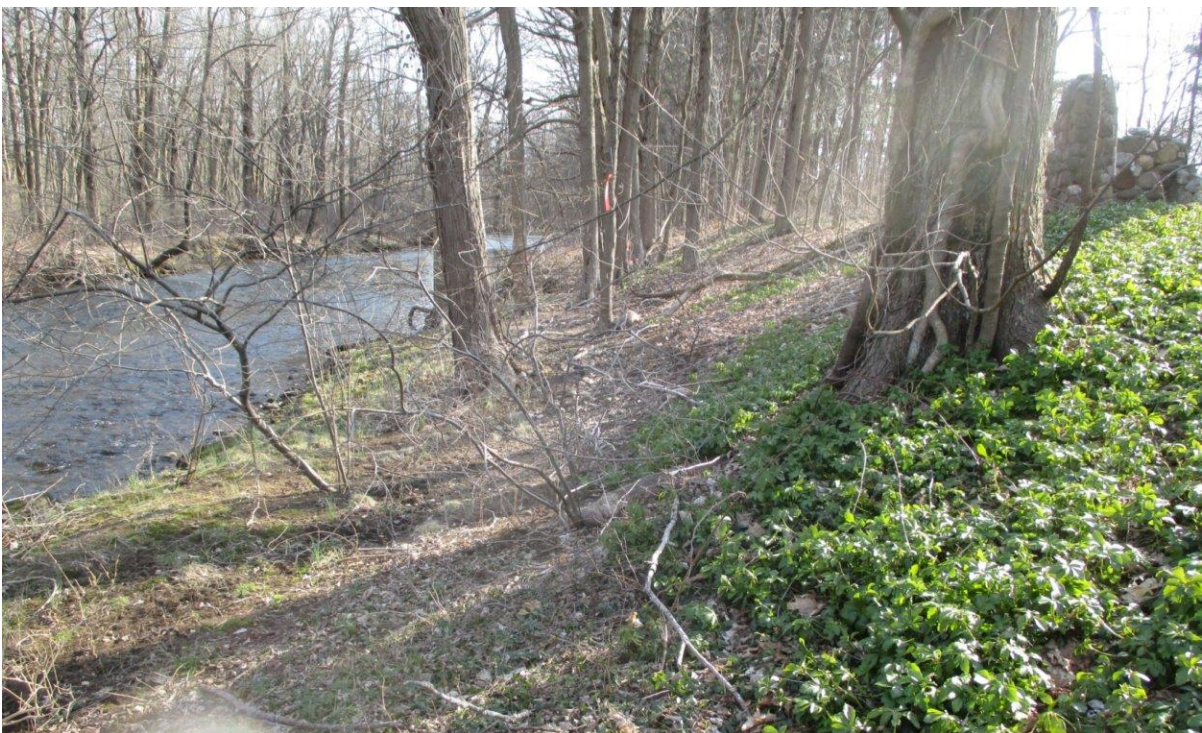
FIREPLACE

Photos taken 03/20/2019. Upper photo facing east; Lower photo facing south, fireplace in upper right corner.

During the March 20 site walk and wetland delineation, an outdoor fireplace was observed behind the garage (upslope from wetland flag A-10). There is also a small "dump" located at the back of the parcel (the south end, near wetland flags A-1 and A-2). The dump contains ceramic items, glass, shells, and slag, among other items (see photos on the following pages). The ages of the fireplace and dump are unknown.

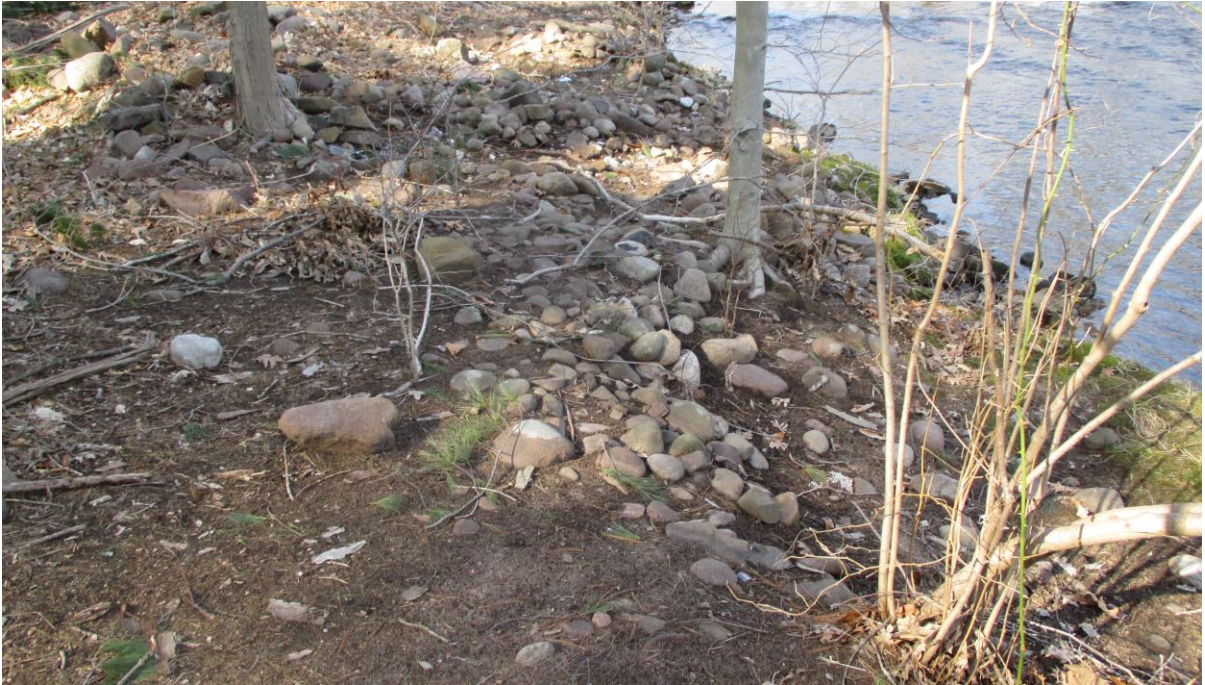
“DUMP” Photos taken 03/20/2019. Facing north (upper photo).

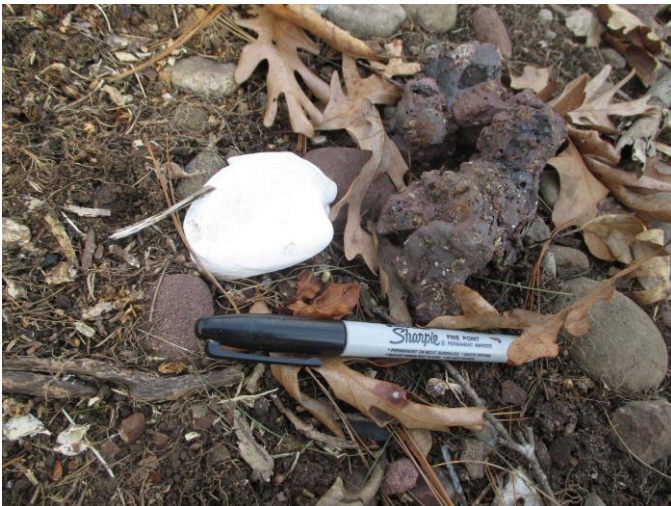
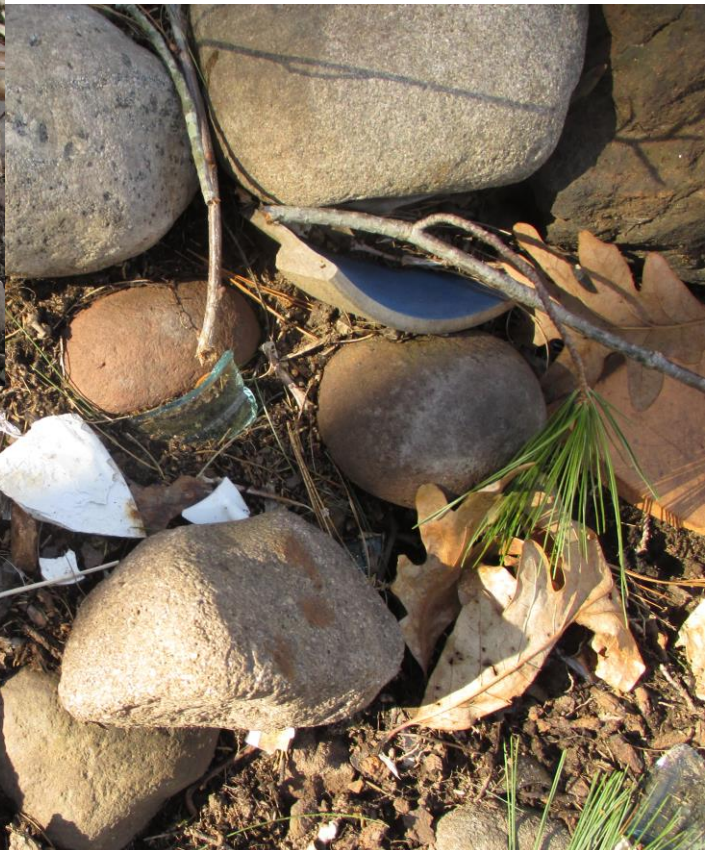
**Shell and slag (left inset)
(note: Sharpie shown for scale)
Glass and dishes (below)
Found in dump**

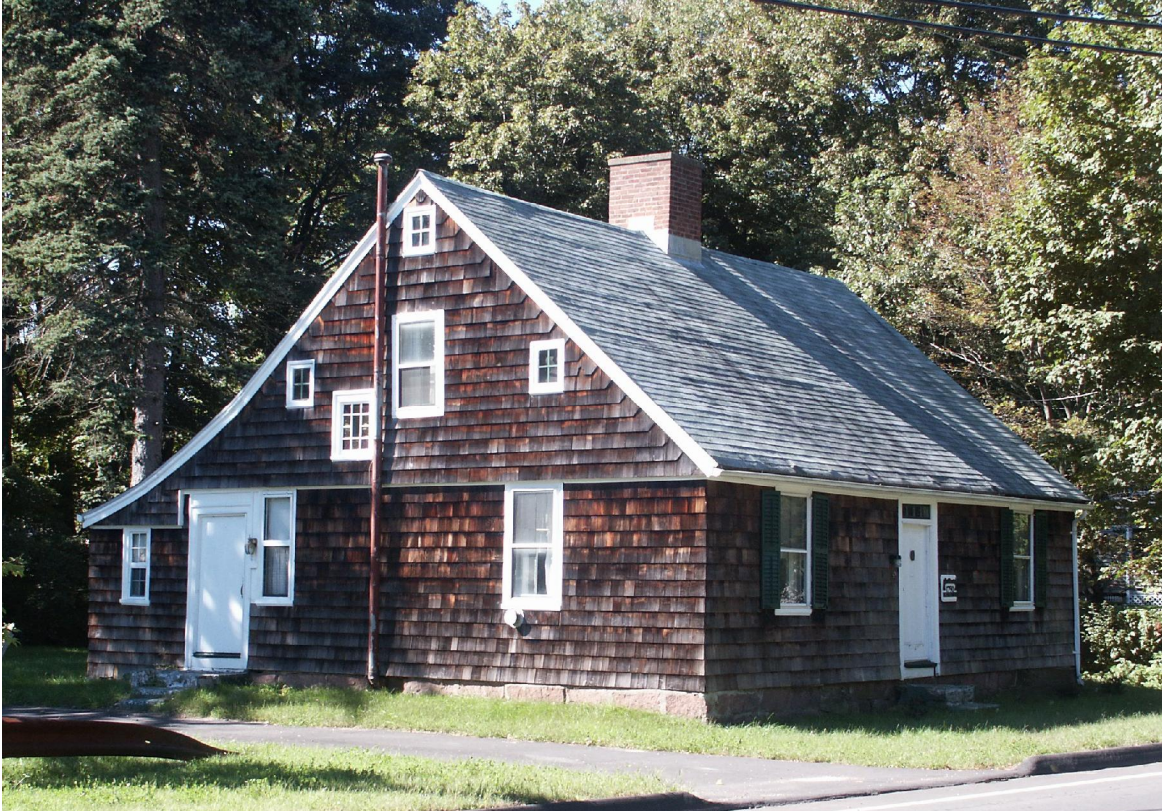
Figure 1 – 95 Ives Street from the northeast.

95 Ives Street is a small one-and-a-half story house with center chimney, located on the south side of Ives Street, a quiet residential street, where it crosses the Mill River. (Figure 1) It is situated with the ridge of its roof parallel to the street. The structure sits on a foundation of cut sandstone (on the north, and for much of the east and west sides) with a rubblestone foundation under the remaining portion of the house. The house sits under a peaked roof with a slight curve or bell-cast to its rear slope. While the 95 Ives Street has been covered in modern wall and roof shingles, the front door moved and many of the windows modified, the house retains much of the exterior character of a building from the end of the 18th century.

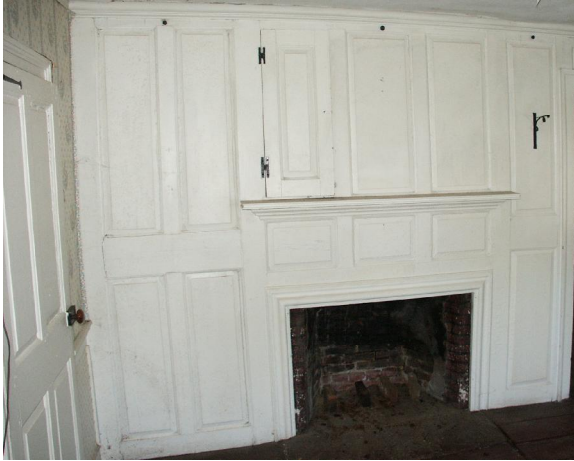
Figure 2 – The paneling in the western front room.

The interior of the building consists of nine rooms on the first floor. Three rooms are aligned across the front of the house, surrounding the chimney on the north, east and west. Each of these has a fireplace. Four more rooms run across the rear of the chimney, with a large central cooking space flanked by an entry and stairs on the east, and two small rooms (most likely the result of a modern division of a single space) on the west. The rear of the divided rooms is a bathroom. Two more enclosed spaces occupy the the rear most portion of the building; these flank a covered and floored open area. Upstairs, the house has two

finished rooms flanking the chimney and a finished space in the southwest corner of the second floor. Only the western front room has a fireplace.

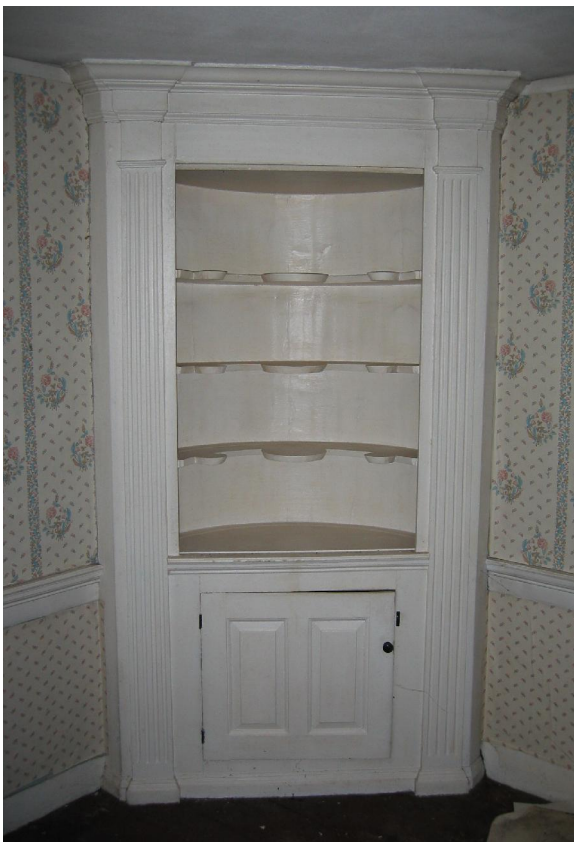
Figure 3 – The corner cupboard.

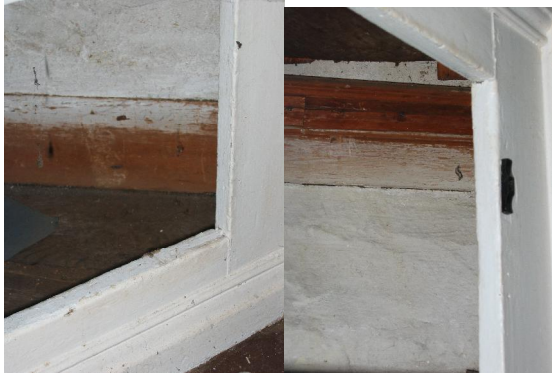
Figures 4 and 5 – Both the baseboard, left, and the chair rail, right, show that the corner cupboard has been in place since before the room received its first coat of paint.

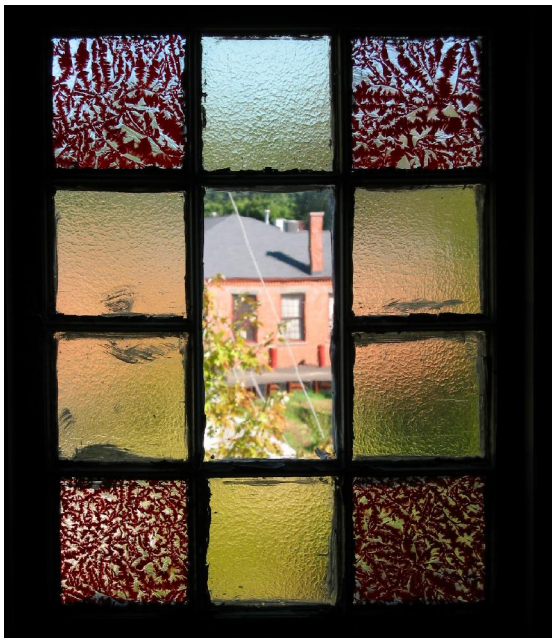
Figure 6 – The art glass window with the Ives factory beyond the river.

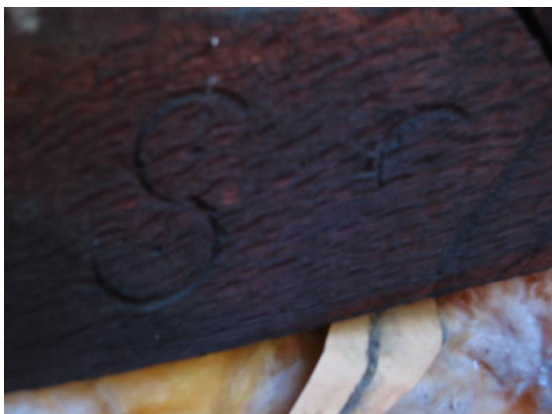
Figure 7 – The carpenter's marks on the brace between the southern plate and southeastern post.

from many of the others in the area is that the carpenter constructing it marked his timbers with reference to cardinal directions rather than simply with more standard raising numerals. (Figure 7) While this evidence is difficult to interpret, it does distinguish 95 Ives Street from other 18th century buildings in the area.

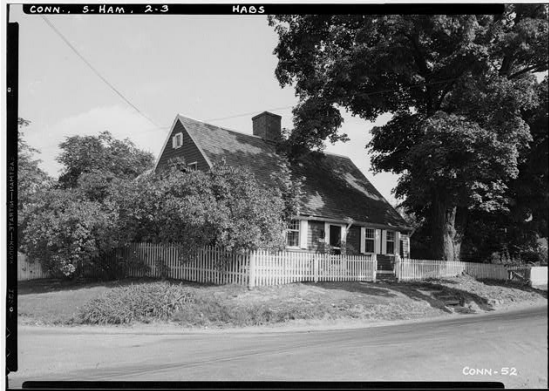
Figure 8 – The exterior of 152 Waite Street in Hamden. (HABS Photo)

The importance of this building is difficult to overestimate. On its own it is a well-preserved example of a late 18th century vernacular architecture. It compares quite favorably with the Moses Ford house of 1769, located at 152 Waite Street, which the Historic American Buildings Survey called “the most perfect dwelling of the Colonial period to be found in Hamden today.” (Figures 8 and 9) The Ives house is also important because of its unusual modified square plan layout and the builder’s use of cardinal directions in addition to raising numerals. But the Elam

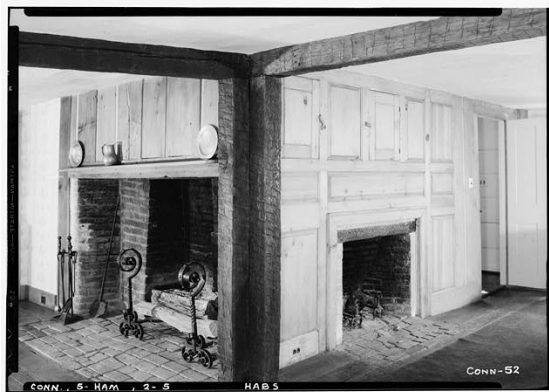
Figure 9 – The interior of 152 Waite Street showing both paneling and the removal of several interior walls. (HABS Photo)
