Application for Approval to the Representative Policy Board: Lake Whitney Dam and Spillway Improvements Project - Phase 1

Application for Approval to the Representative Policy Board: Lake Whitney Dam and Spillway Improvements Project – Phase 1

HYDROLOGY AND HYDRAULICS ANALYSIS SUMMARY REPORT LAKE WHITNEY DAM Hamden/New Haven, CT

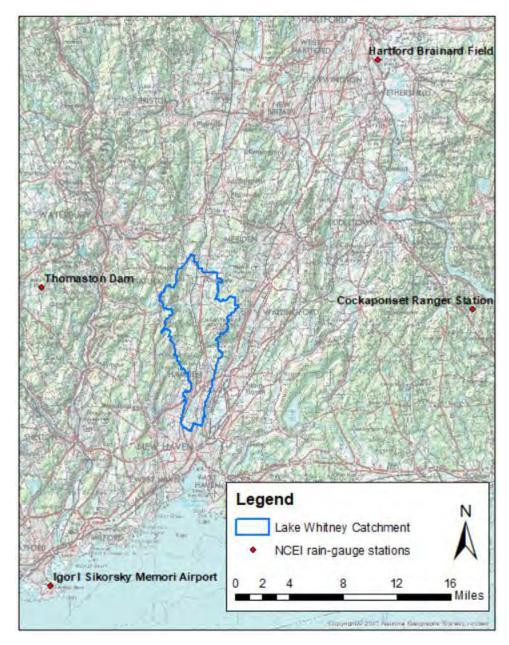
Figure 2: Stations with precipitation Data available from NOAA's National Centers for Environmental Information (NCEI)

Local rainfall estimates for historical floods are required to calibrate a gauged watershed's response. GZA collected precipitation data from the following stations in Connecticut (Figure 2):

- 068330: Thomaston Dam in Thomaston, CT, 12 miles northwest of the catchment, period of record: 1961-2014
- 063451: Hartford Brainard Field, 25 miles northeast of the catchment, period of record: 1947-2008
- 061488: Cockaponset Ranger Station, 20 miles east of the catchment, period of record: 1978-2012
- 060806: Igor I Sikorsky Memorial Airport, 20 miles southwest of the catchment, period of record: 1948-2013

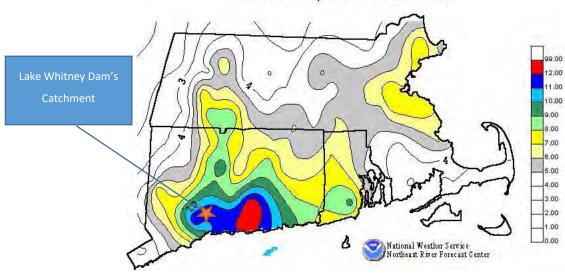
Figure 3: Rainfall totals across Southern New England from June 4-7, 1982 (weather.gov) Lake Whitney's catchment marked on the map

June 4-7, 1982 Rainfall

The June 1982 event is the flood of record at the gauging station at Mill River, bringing a total of 9.7 inches of rainfall from June 4th to June 7th. This is estimated based on available precipitation data from rain-gauges and calculating a weighted average (10% Thomaston Dam, 90% Cockaponset station) based on spatial distribution of the precipitation developed by National Weather Services (Figure 3), which shows high precipitation in Hamden with extremely high values at Cockaponset rain gauge.

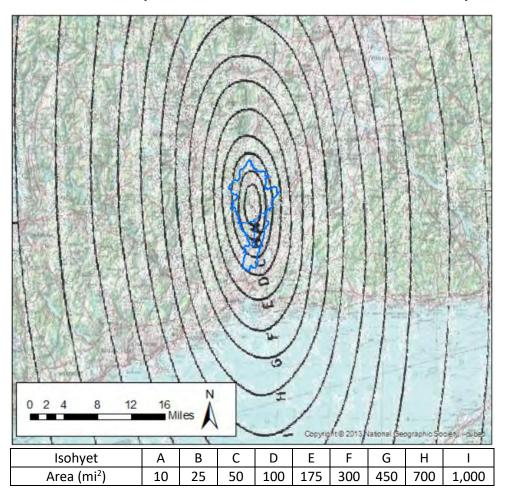
HMR52 Standard Isohyetal Pattern and Storm Orientation for Lake Whitney Dam Catchment

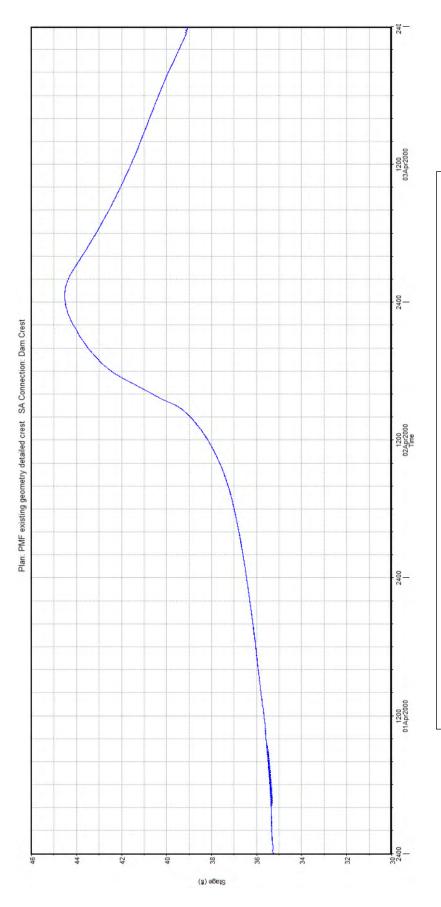
Results of PMF routing in HEC-RAS: Water Surface Elevation at the Dam Crest During PMF

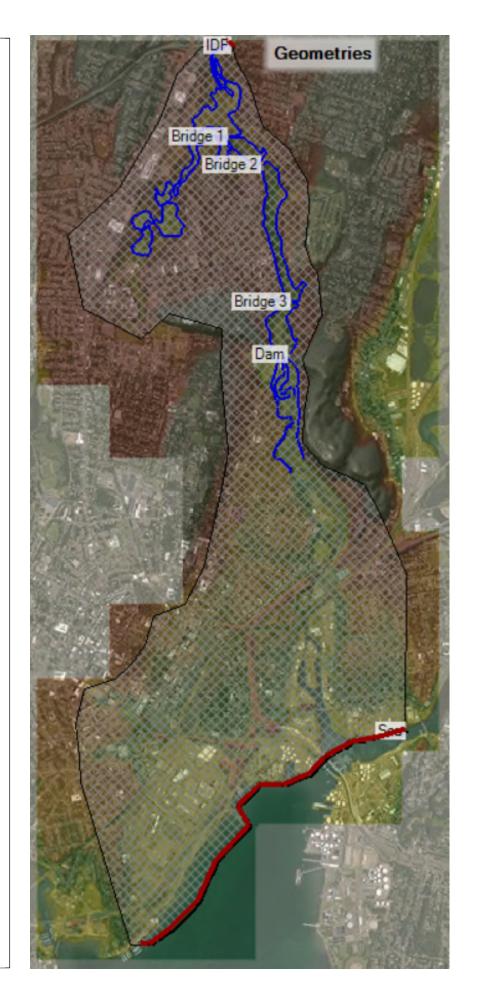
Appendix E – Lake Whitney Dam HEC-RAS model extents

Meshed Area: 2D Flow. Red Lines: Upstream and Downstream Boundary Condition. Blue Lines: Break-lines. Grey Lines: Structures

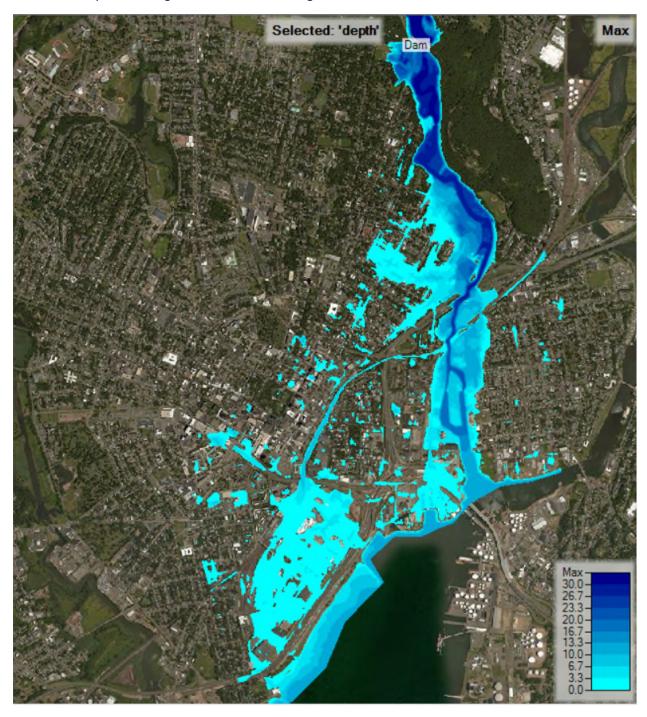
Max water depth resulting from Dam break during PMF

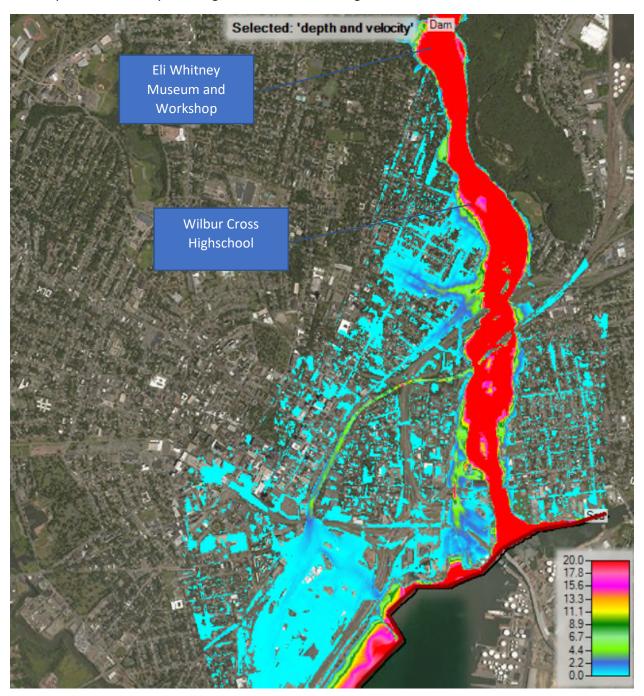
Max Depth times Velocity resulting from Dam break during PMF

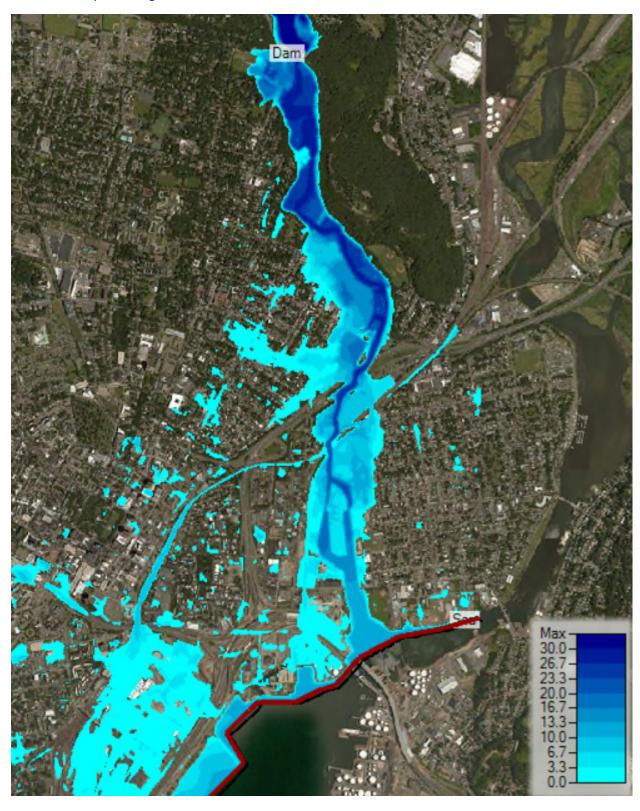
Max water depth during PMF

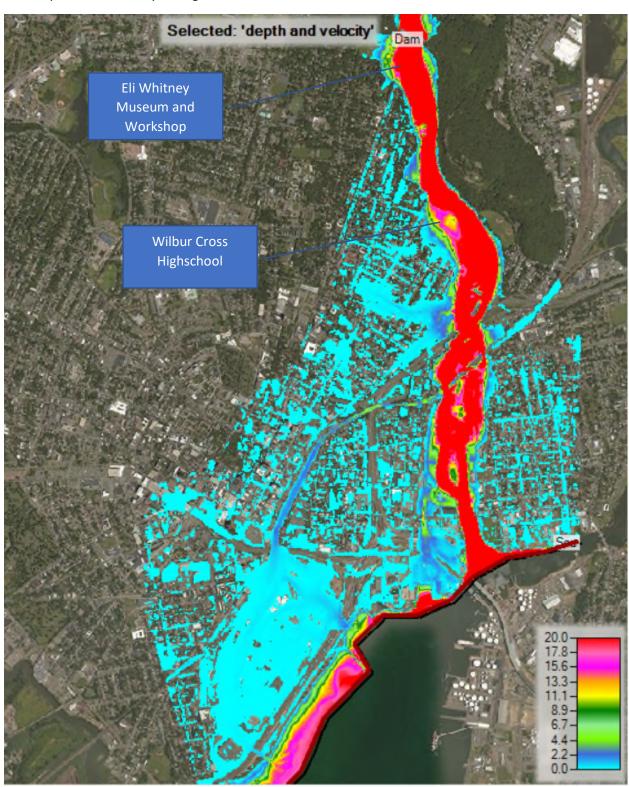
Max Depth times Velocity during PMF

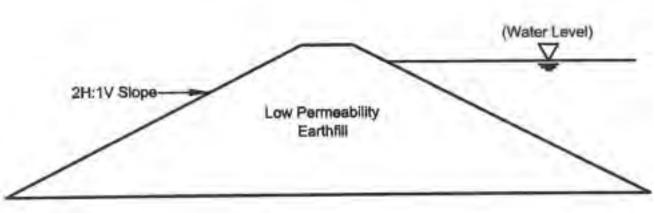
Earthfill Dam

- a. Earthfill Dam: in which more than 50% of the volume consists of soil. This type of dam is often referred to as an Embankment Dam.
- Zone Embankment Dam: composed of zones of selected materials having different degrees of permeability.

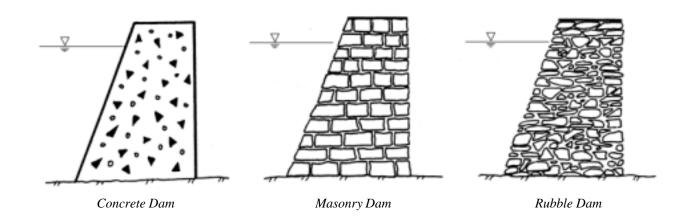
Masonry Wall//Earthfill Dams

- c. Masonry Dam: constructed mostly of shaped stone, brick or concrete blocks that may or may not be joined by mortar.
- d. Rubble Dam: constructed of unshaped coarse stone or fragments of stones, not placed in courses, that may or may not be joined by mortar.
- e. Masonry Wall/Earthfill Dams: consisting of earth embankment with one or two masonry rubble rock

- faces; walls on downstream and/or upstream faces are generally vertical.
- f. Concrete Dam: constructed primarily of cast-inplace concrete.
- g. Concrete Wall/Earthfill Dam: consisting of earth embankment with one concrete wall, generally vertical and on the upstream face.

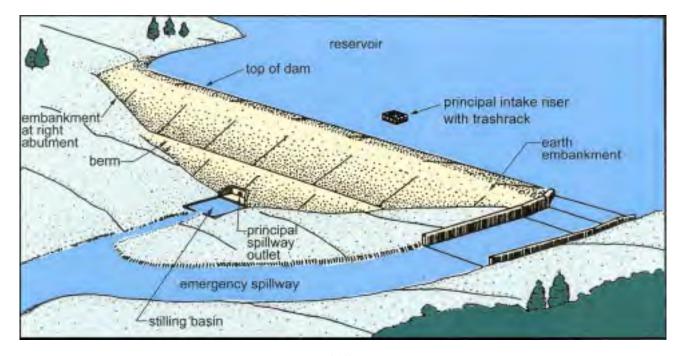
Earthfill Dam

The common components of a typical earthfill dam are illustrated below. Descriptions of some common dam components are also given below.

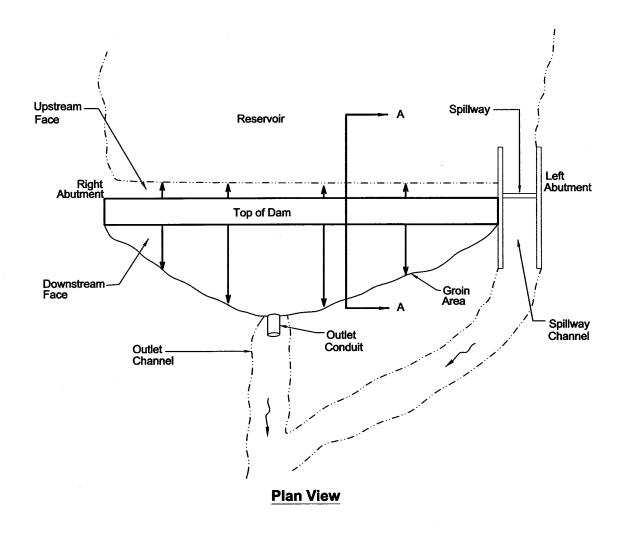
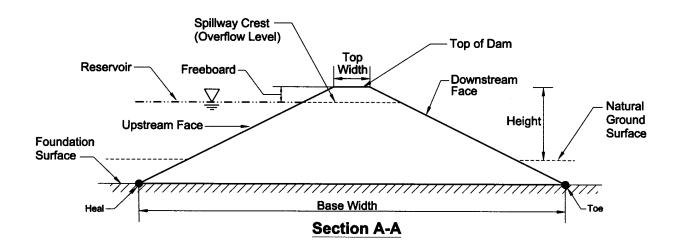
Section Through Dam

The embankment is the primary part of the dam. It is the section which impounds and resists the forces of the water. A homogeneous embankment is composed of essentially the same material throughout, while a zoned embankment has different materials, such as clay or rock, incorporated into some areas. Seepage through the dam embankment may be collected and controlled by an internal drainage system such as a toe drain or foundation drain.

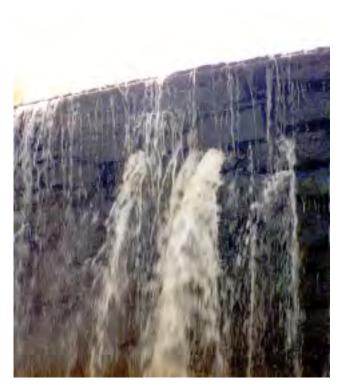
Leak in Masonry Wall

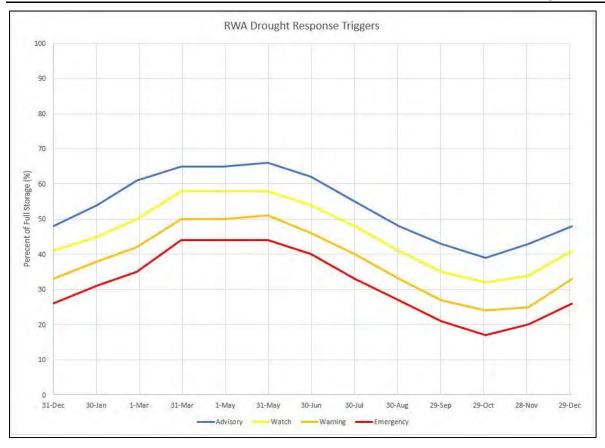
Figure 1 - Drought Response Triggers

Table 2
Drought Stages

Stage	Type of Restrictions	Target Demand Reduction
Advisory	Voluntary	10%
Watch	Voluntary	15%
Warning	Mandatory	20%
Emergency	Mandatory	25%

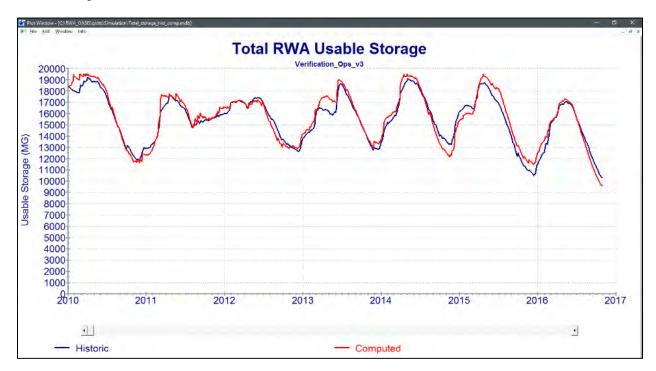
Figure 2 Reservoir Model Validation

between reservoirs. Reservoir inflow was based on adjusted USGS Stream Gage data, validated based on recent reservoir performance. Figure 2 compares modeled to historic reservoir storage for RWA's combined reservoirs and demonstrates the strong model validation that was achieved. The model validation was similarly evaluated for each individual reservoir system.

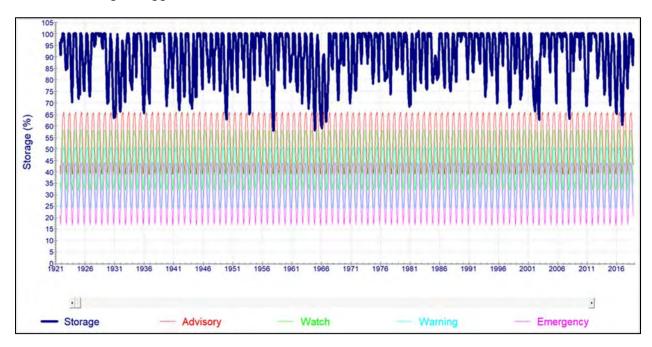
Figure 3 Reservoir Drawdown Under Current Conditions

To evaluate the susceptibility of RWA's system to drought the OASIS model was used to simulate reservoir performance over the historic period of record for which USGS stream gage and precipitation data were available, utilizing current system demands and reservoir operating rules. Figure 3 presents the resulting modelled total system storage in comparison to RWA's drought triggers.

The minimum storage that RWA's reservoir system would have reached over the almost 100 years modeled under current demands and operations was 58%, in 1957. In addition, the model simulated no occurrences of any drought stages over this time period. This analysis indicates that RWA's reservoir system is currently at low risk for significant drought impact when fully utilized.

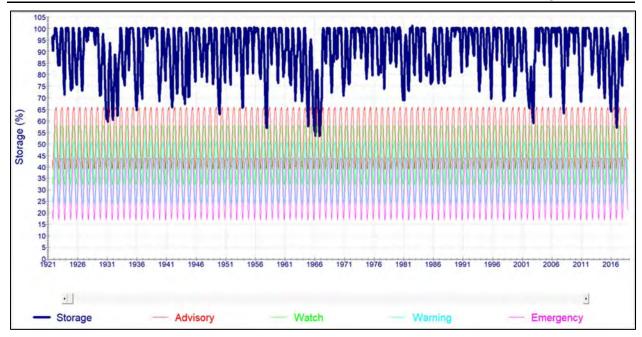
Figure 4 - Reservoir Drawdown With New Stream Flow Regulation Releases

Figure 4 presents the modelled total reservoir storage over the period of available records utilizing current demands and operations and reservoir releases in compliance with the new DEEP Stream Flow Regulations.

The minimum storage that RWA's reservoir system would have reached over the almost 100 years modeled under current demands and operations would have been 54%, in 1966. In addition, the model simulated no occurrences of any drought stages over this time period. This analysis indicates that the RWA's reservoir system, when fully utilized, will remain at low risk for significant drought impact after implementation of the Stream Flow Regulation release requirements.

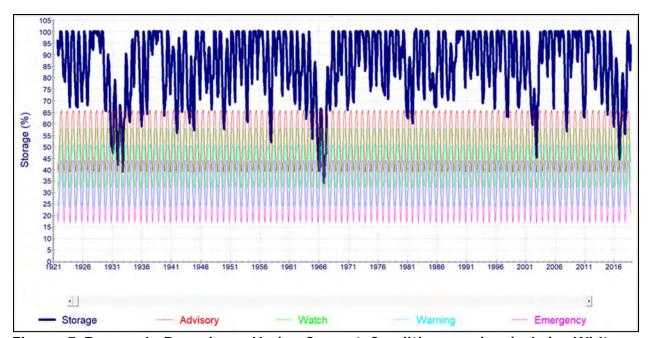
Figure 6 – Reservoir Drawdown with new Streamflow Regulation Releases and w/o Lake Whitney

Figures 5 and 6 illustrate the impact of not using Lake Whitney on total reservoir storage under current demands as modeled from 1921 through 2017.

The minimum system storage without Lake Whitney would have been 34% under current release requirements and 24% under future Stream Flow Regulation release requirements, both in 1966. Minimum storage in the North Branford Reservoir System, which would need to increase production to offset the lost production from Lake Whitney, would have been 22% under current releases and 6% under future releases. In addition, without Lake Whitney the model predicts that RWA's system would have experienced five Drought Advisories, three of which would have become Drought Watches, over the nearly 100 years simulated under current demands and release requirements. With the future Streamflow Regulations release requirements this drought frequency would have increased to six Drought Advisories, four of which extend through Watch, Warning and into Emergency, over the period simulated.

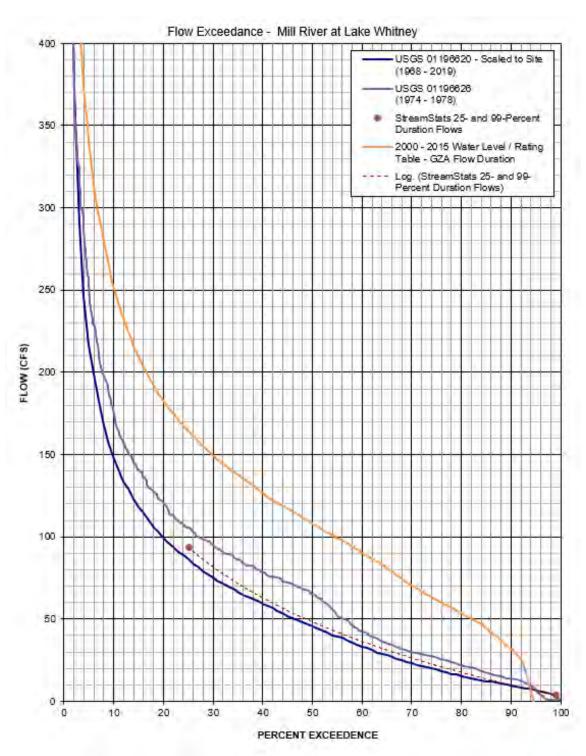
Figure 2: Design Flow Duration Curves for Mill River at Lake Whitney Dam

Based on GZA's evaluation of the above described data, we developed a synthetic flow duration curve so as not to underestimate flows at the site. GZA developed the synthetic flow duration record by applying a factor of 1.16x to the long-term flow duration curve developed from USGS gage 01196620 to increase the 25-percent exceedance flow from 86 cfs to 100 cfs. GZA recommends a 25-percent exceedance flow equal to 100 cfs which is within the range of the estimates developed by GZA and Haestad for the dam. As previously noted, GZA's believes that the 2017 HDR analysis overestimates the available flow due to multiple factors. The synthetic flow duration curve is presented in **Figure 2** and the tabular data is presented within Table 3 of Attachment B.
