Application for Approval to the
Representative Policy Board: Lake
Whitney Dam and Spillway
Improvements Project - Phase 1

**HYDROLOGY AND HYDRAULICS ANALYSIS
SUMMARY REPORT
LAKE WHITNEY DAM
Hamden/New Haven, CT**

April 2, 2020

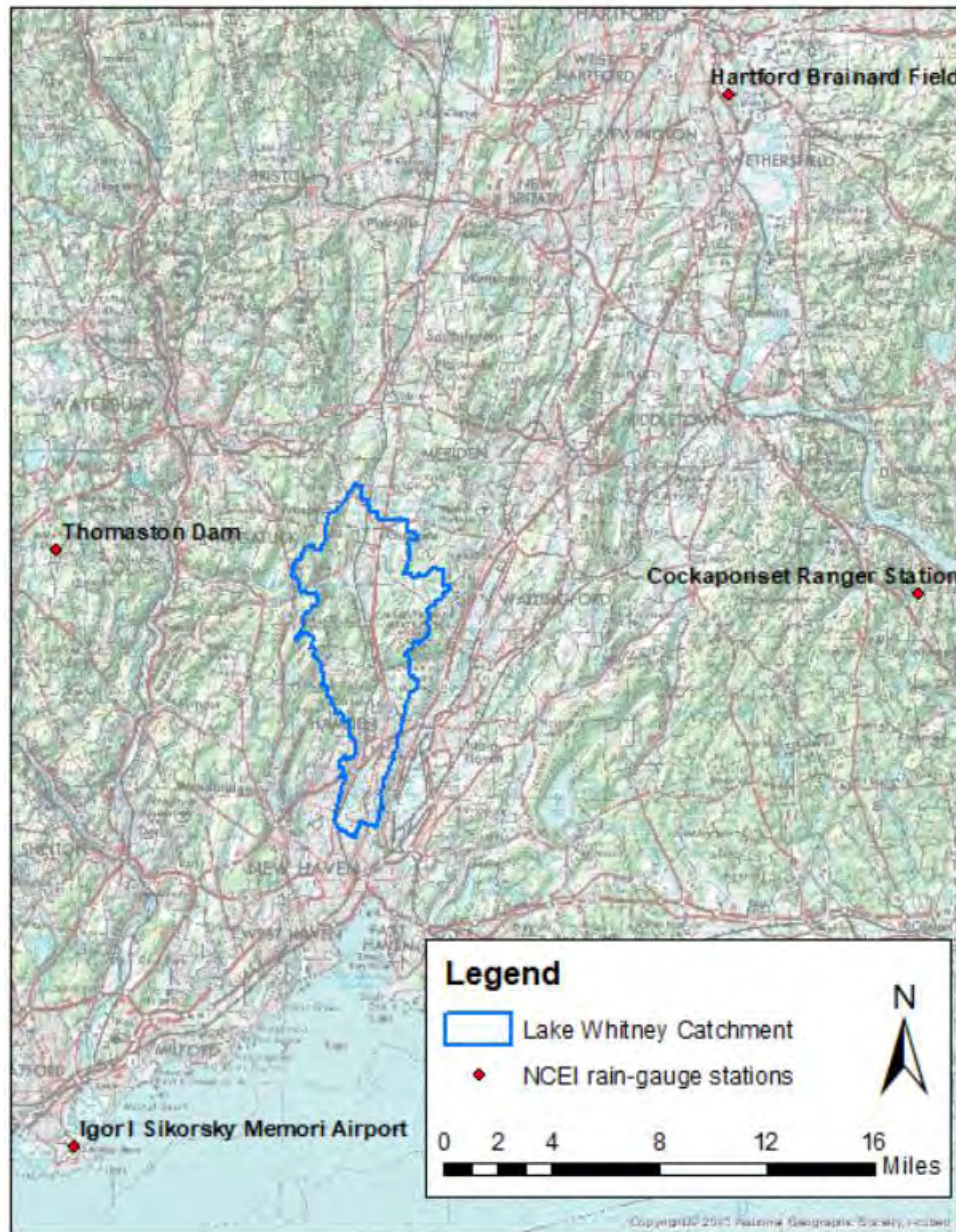
Figure 2: Stations with precipitation Data available from NOAA's National Centers for Environmental Information (NCEI)

Local rainfall estimates for historical floods are required to calibrate a gauged watershed's response. GZA collected precipitation data from the following stations in Connecticut (Figure 2):

- 068330: Thomaston Dam in Thomaston, CT, 12 miles northwest of the catchment, period of record: 1961-2014
- 063451: Hartford Brainard Field, 25 miles northeast of the catchment, period of record: 1947-2008
- 061488: Cockaponset Ranger Station, 20 miles east of the catchment, period of record: 1978-2012
- 060806: Igor I Sikorsky Memorial Airport, 20 miles southwest of the catchment, period of record: 1948-2013

Precipitation in Lake Whitney Dam's catchment was estimated based on the available data. Based on the location of the rain gauges and relatively small size of Lake Whitney's catchment compared to the distances between gauges, GZA used the inverse distance method:

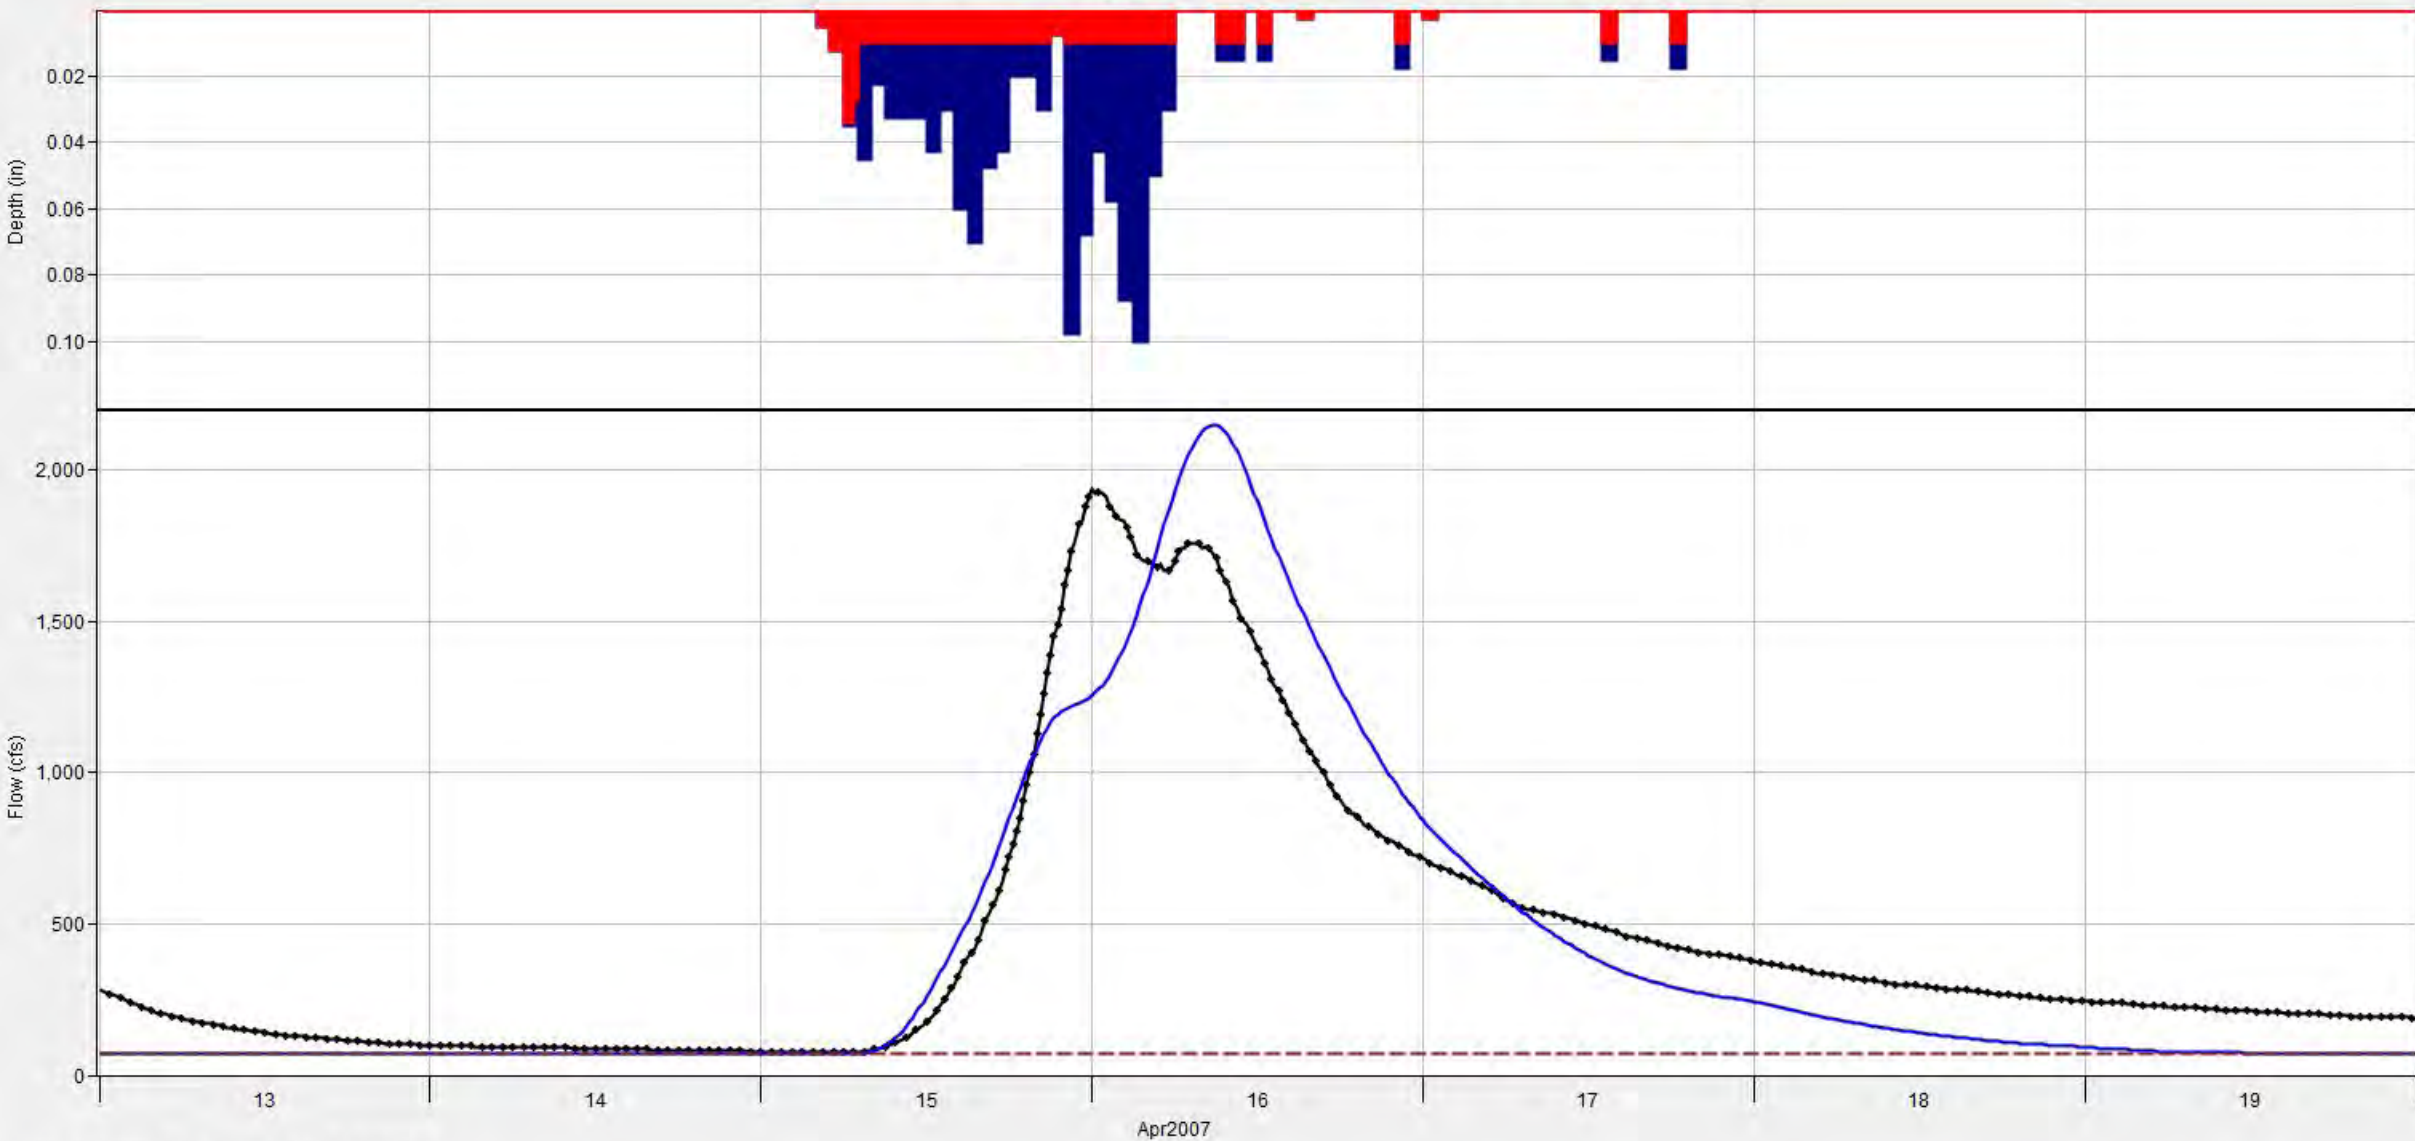
Subbasin "Gauging Station" Results for Run "April 2007"

Run: April 2007 Element: Gauging Station Result: Precipitation

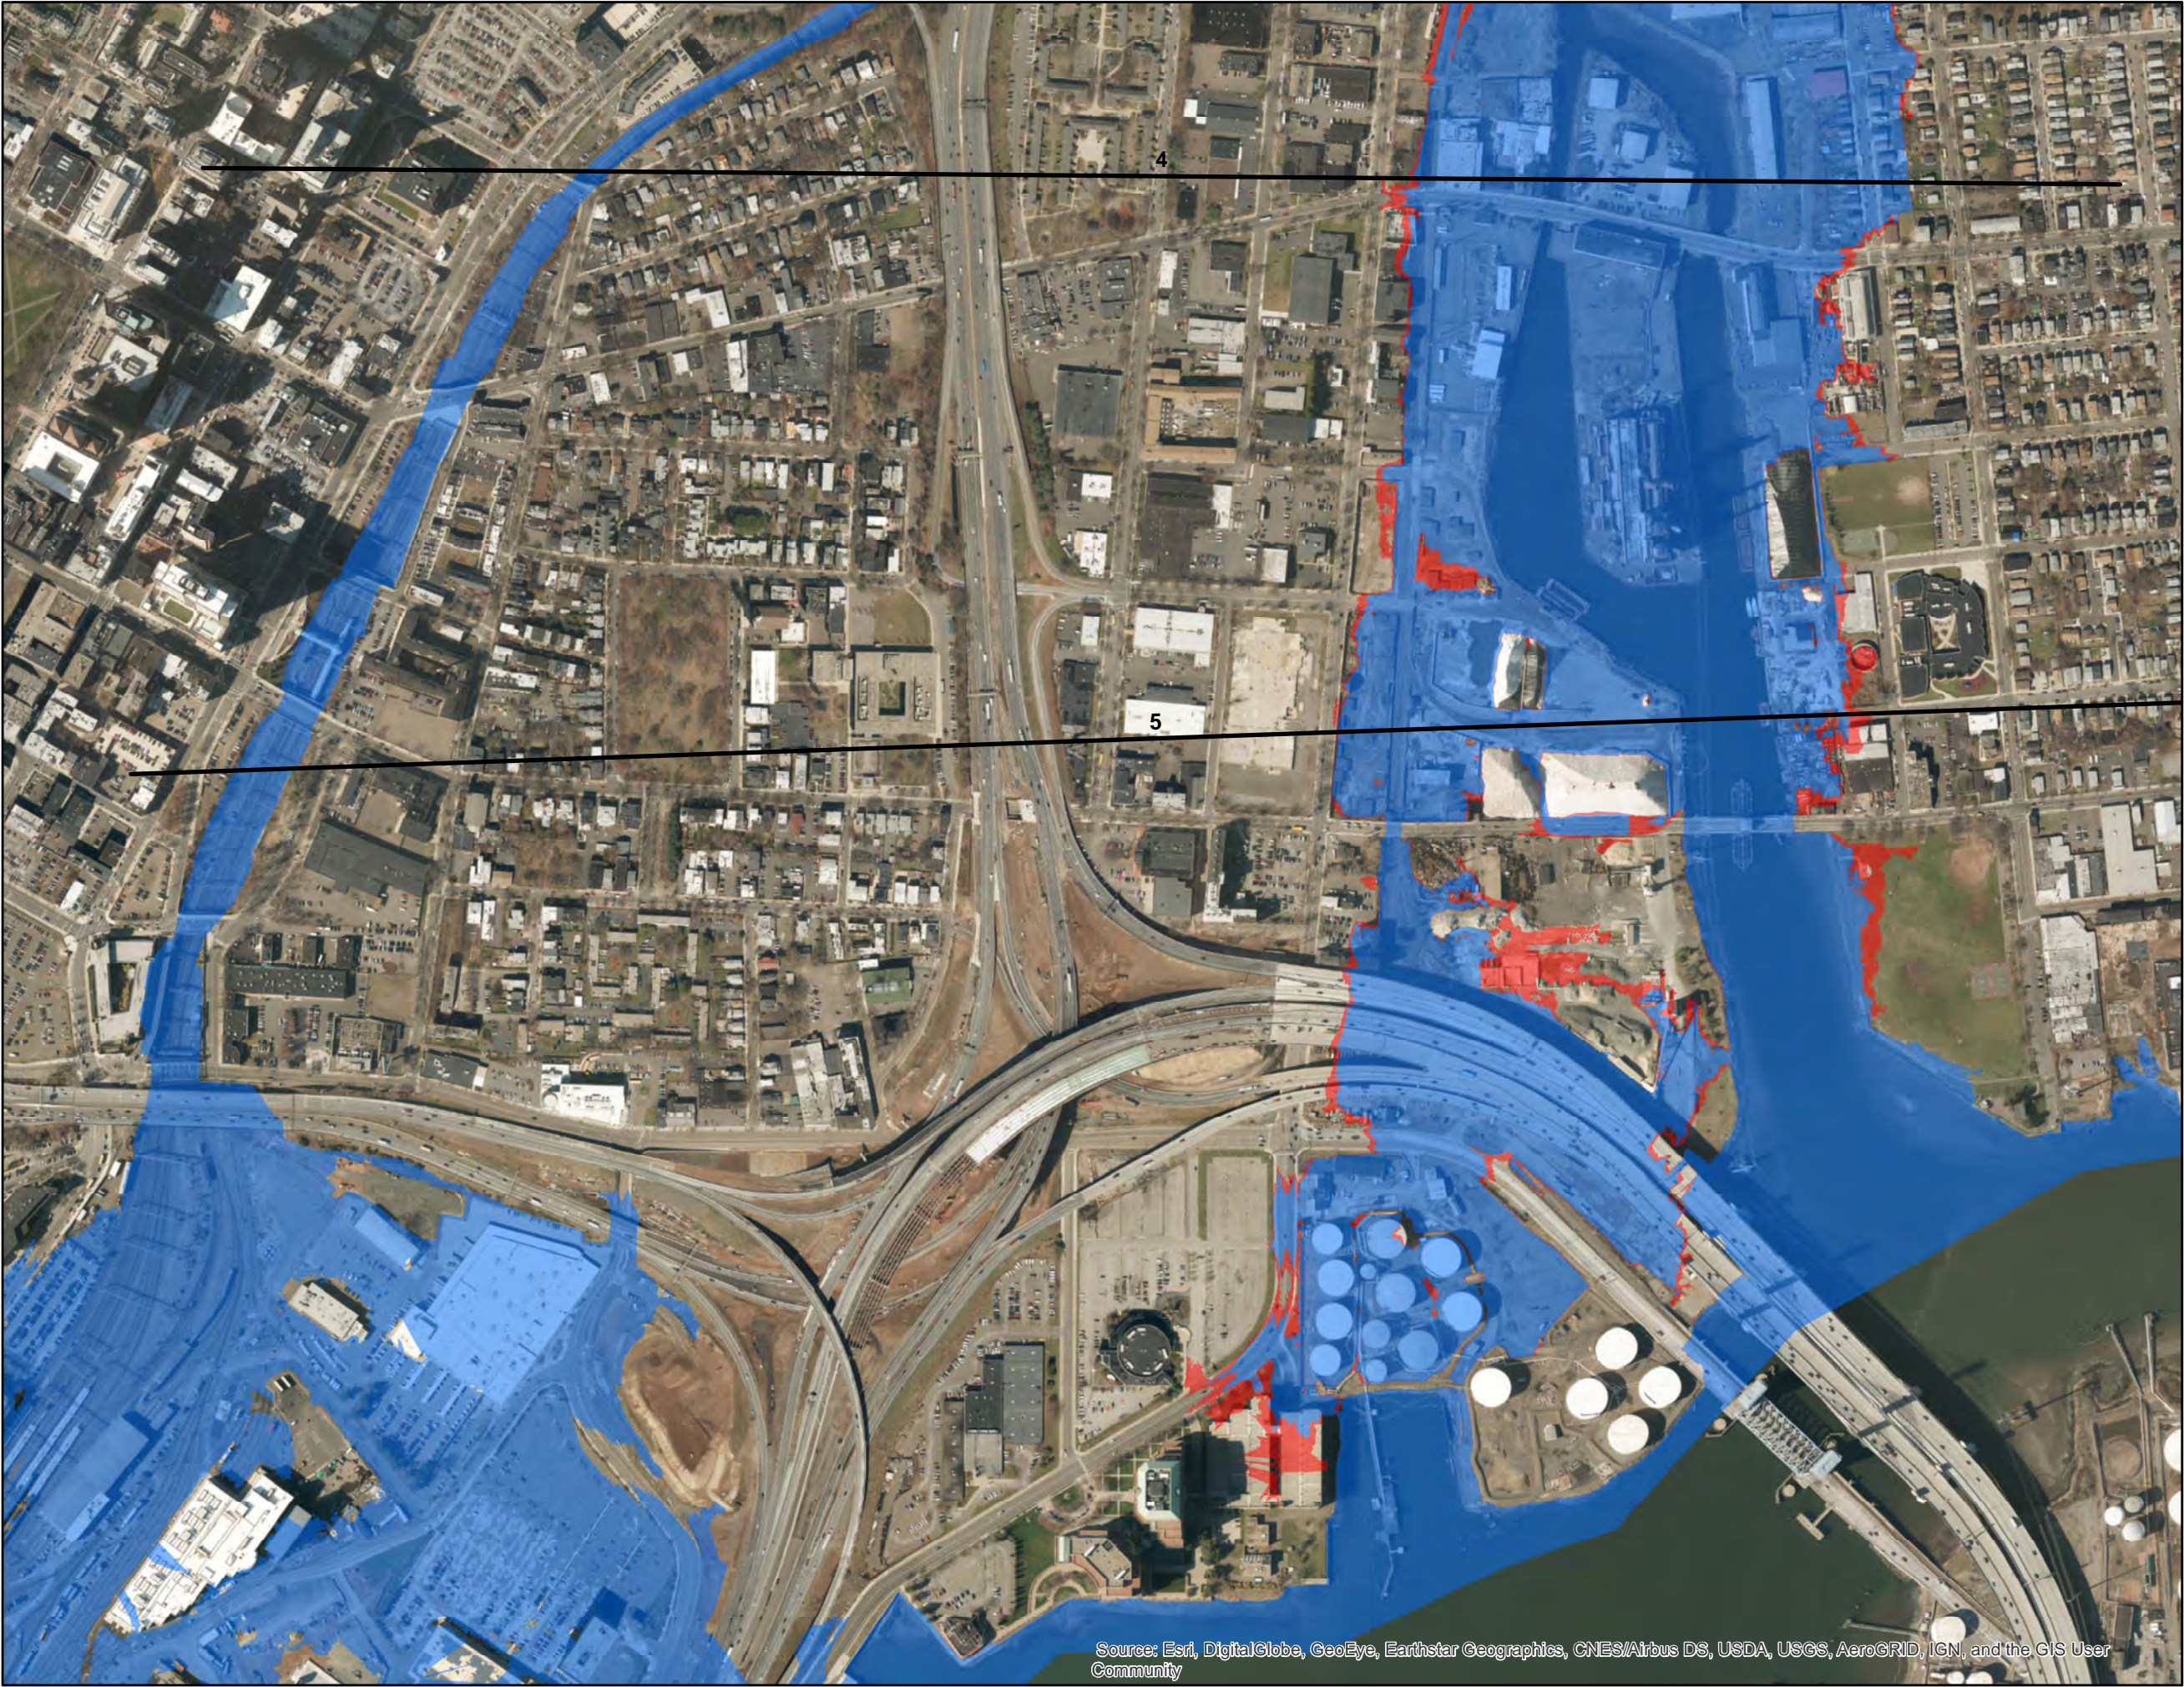
- Legend**
- Locations verified in ICA
 - PMF Flood
 - Dam Break During PMF Flood

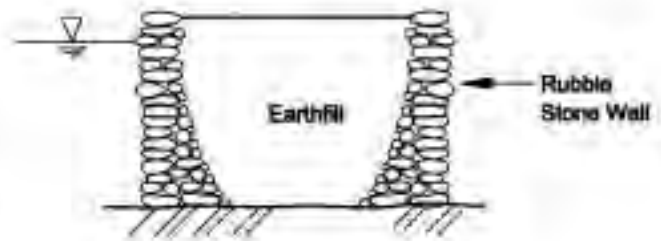
- c. Masonry Dam: constructed mostly of shaped stone, brick or concrete blocks that may or may not be joined by mortar.
- d. Rubble Dam: constructed of unshaped coarse stone or fragments of stones, not placed in courses, that may or may not be joined by mortar.
- e. Masonry Wall/Earthfill Dams: consisting of earth embankment with one or two masonry rubble rock faces; walls on downstream and/or upstream faces are generally vertical.
- f. Concrete Dam: constructed primarily of cast-in-place concrete.
- g. Concrete Wall/Earthfill Dam: consisting of earth embankment with one concrete wall, generally vertical and on the upstream face.

Masonry Wall/Earthfill Dams

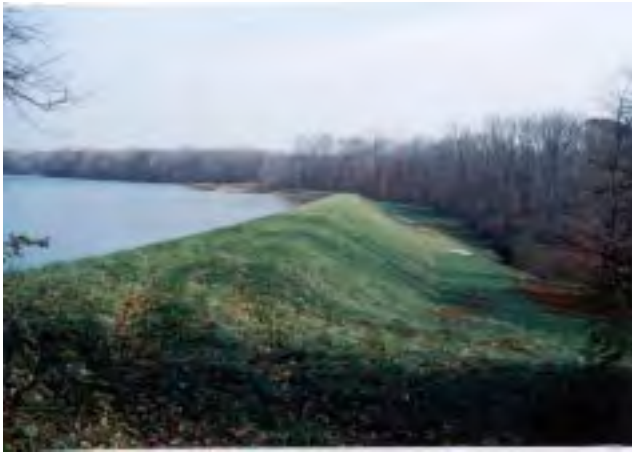
The embankment is the primary part of the dam. It is the section which impounds and resists the forces of the water. A homogeneous embankment is composed of essentially the same material throughout, while a zoned embankment has different materials, such as clay or rock, incorporated into some areas. Seepage through the dam embankment may be collected and controlled by an internal drainage system such as a toe drain or foundation drain.

Well Maintained Embankment

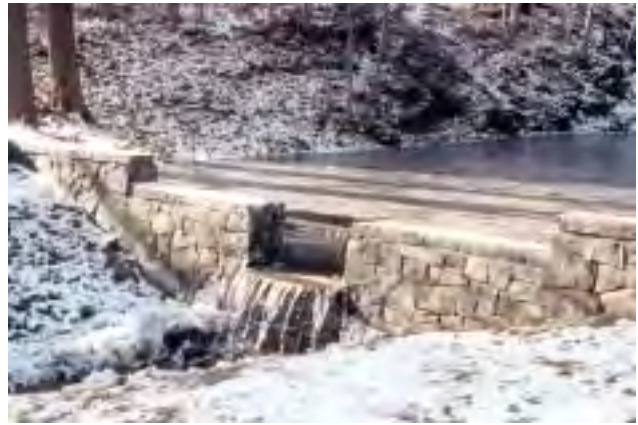
The principal spillway establishes the normal water level of the pond or lake. The function of the principal spillway is to allow normal flow to pass the dam in a safe and non-erosive manner. An emergency spillway is an auxiliary spillway designed to pass flood flows greater than the principal spillway's capacity in order to prevent the dam from overtopping during extreme storms. Spillways must be resistant to erosion because their failure may be as significant as an embankment failure and may well lead to dam failure. Because flows in spillways may reach high velocities, a stilling basin or plunge pool is often used to prevent erosion.

Spillway

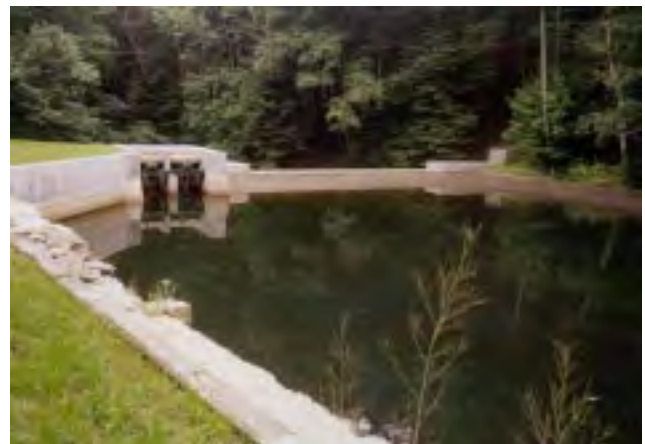
Also referred to as drawdown facilities, these structures help control impoundment levels and drain a reservoir for normal maintenance or emergency purposes. Most drawdown facilities consist of a pipe through the dam with a valve which may be operated as needed. The dam spillway and drawdown structures may be built in close proximity to one another, and an outlet structure may be incorporated into the principal spillway structure.

Intake Structure

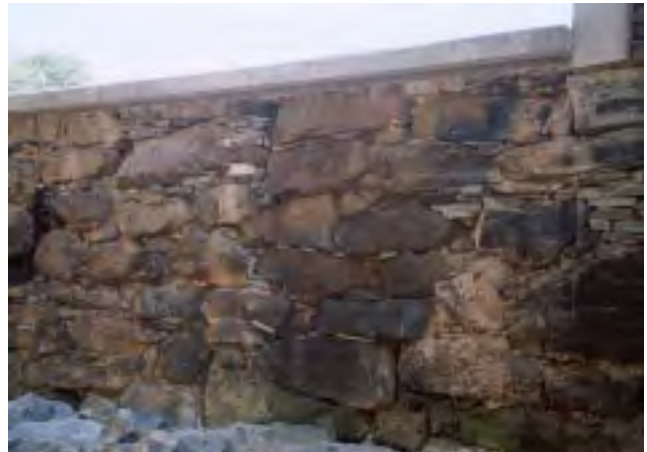
Many masonry and rubble-wall-faced earth dams exist in Connecticut. In some instances properly graded gravel was placed immediately behind the wall to provide a drainage outlet for any seepage moving through the earthfill. Spillway and spillway training walls have also been constructed with masonry/rubble walls. Evidence of any seepage, subsidence or undercutting of these walls is best observed with the impoundment at spillway crest elevation to assess whether the crest is level. The structure should then be viewed with no flow over the spillway to assess the degree and location of seepage/leakage and the presence of scour or undercutting erosion at the toe.

Rubble Wall

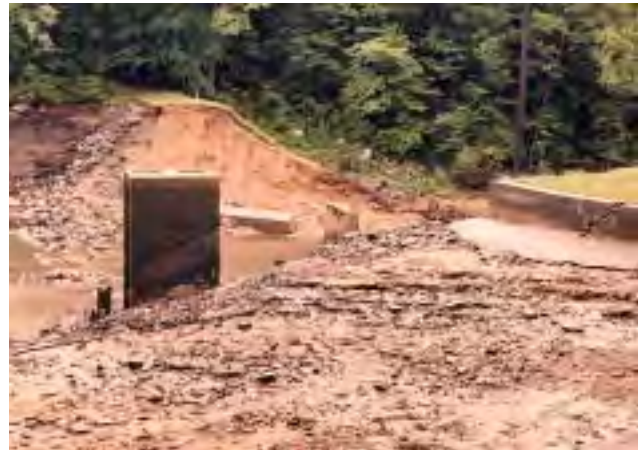
Overtopping failures result from the erosive action of the uncontrolled flow of water over, around or adjacent to the dam. Earth embankments are not designed to be overtopped and therefore are particularly susceptible to erosion. Surface erosion may reduce the embankment cross-section, saturate an earth embankment and lead to a structural failure. General causes of overtopping include inadequate spillway size and/or spillway blockage by debris.

Dam Failure

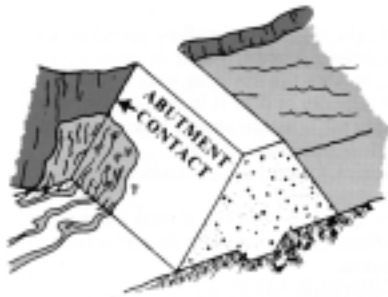
Seepage Water Exiting at Abutment Contact

Can lead to erosion of embankment materials and failure of the dam.

Study leakage area to determine quantity of flow and extent of saturation. Stake out the saturated area and monitor for growth or shrinkage. Inspect frequently for slides. Water level in the impoundment may be lowered to increase embankment safety. A **QUALIFIED ENGINEER** should inspect the conditions and recommend further actions to be taken.

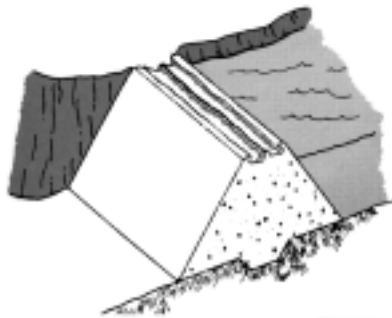
Ruts/Puddling Along Crest

Allows standing water to collect and saturate crest of dam. Vehicles can get stuck.

Regrade and recompact crest to provide proper drainage to upstream slope. Install gravel or road base material to accommodate traffic.

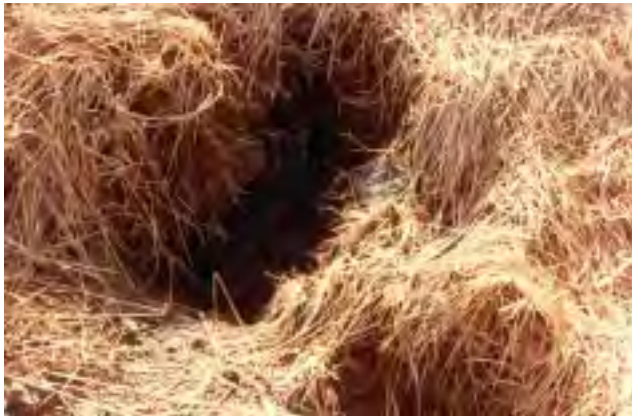
- a. Vegetation Control - twice per year
 - Mow grass to maintain visibility of dam surfaces and remove woody vegetation from within 25 feet of all dam components
 - Maintain a healthy stand of grass to prevent erosion and growth of woody vegetation
- b. Rodent Control - as required
 - Fumigate burrow
 - Trap or eradicate rodent
 - Fill entire burrow with fill material

Rodent Burrow

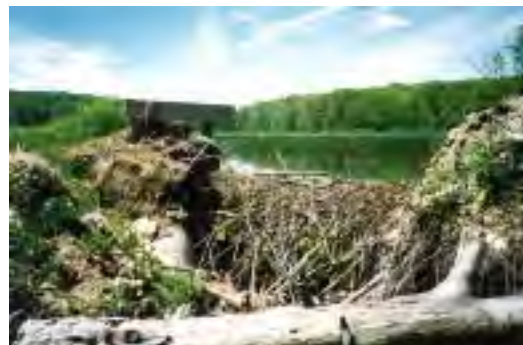
- e. Beaver Dam Removal - as required
 - Remove beaver flowage debris from spillway

Beaver Dam in Spillway

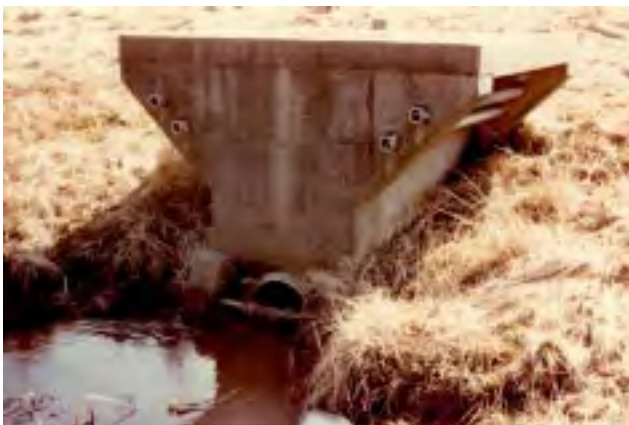
- a. Trashrack - after every major storm
 - Remove accumulated debris
 - Repair rusted or broken sections as needed
- b. Mechanical - once per year
 - Cycle (open and close) outlet gate valves through full operating range
 - Lubricate mechanisms per manufacturer's recommendation
 - Paint or grease ferrous metal surfaces as needed
 - Align stem guides or brackets
- c. Internal Conduit - once per year
 - Check for undermining or seepage around the outlet end
 - Check for corrosion or other deterioration of conduit material
 - Should deficiencies be detected, obtain immediate professional guidance before attempting repairs
- d. Concrete Features - once per year
 - Check for misalignment, cracks, spalls, scaling, exposed steel rebar, rust stains
 - Consult with DEP Dam Safety Personnel or a consultant engineer before attempting repairs

Concrete Intake Structure

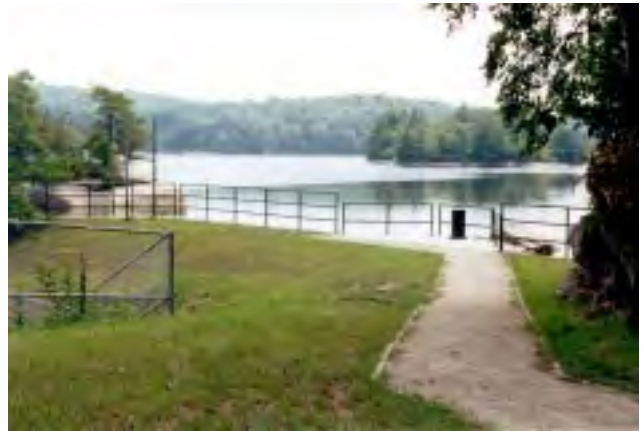
- a. Maintain vehicular and pedestrian access features to allow future inspection and maintenance - once per year.
- b. Check fences, locks and signs for damage - once per year.

Walkway, Hand Railing

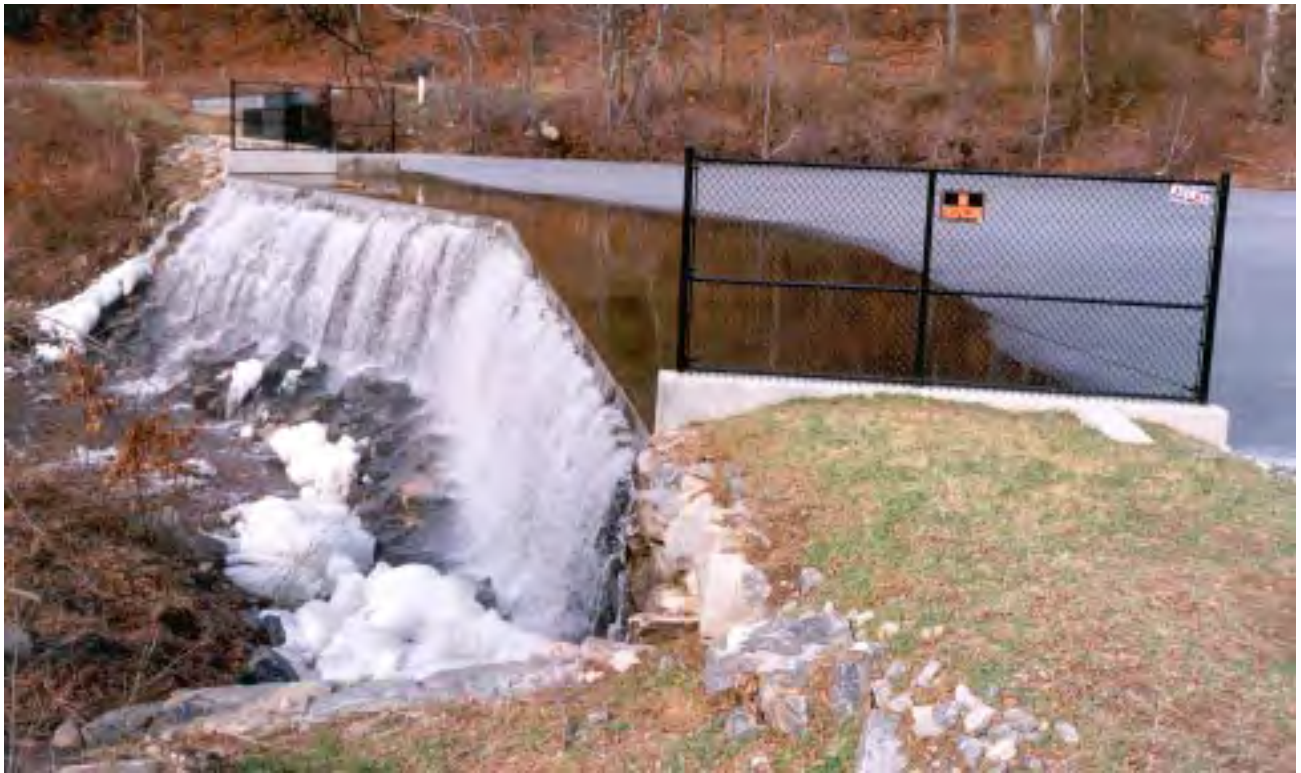
Fence and Signage
