Application for Approval to the
Representative Policy Board: Lake
Whitney Dam and Spillway
Improvements Project - Phase 1

Engineering Report

HYDROLOGY AND HYDRAULICS ANALYSIS SUMMARY REPORT LAKE WHITNEY DAM Hamden/New Haven, CT

April 2, 2020

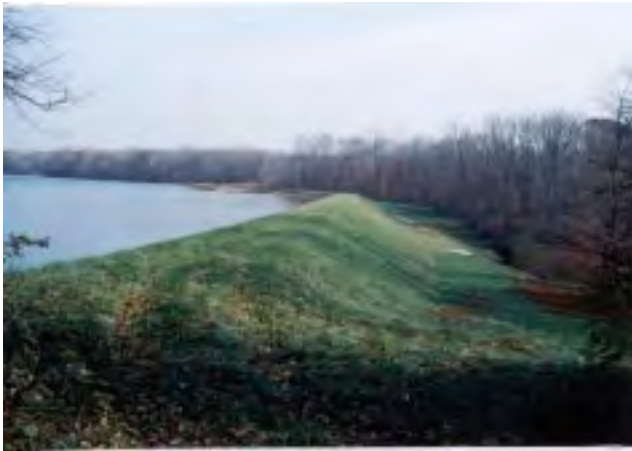
The embankment is the primary part of the dam. It is the section which impounds and resists the forces of the water. A homogeneous embankment is composed of essentially the same material throughout, while a zoned embankment has different materials, such as clay or rock, incorporated into some areas. Seepage through the dam embankment may be collected and controlled by an internal drainage system such as a toe drain or foundation drain.

Well Maintained Embankment

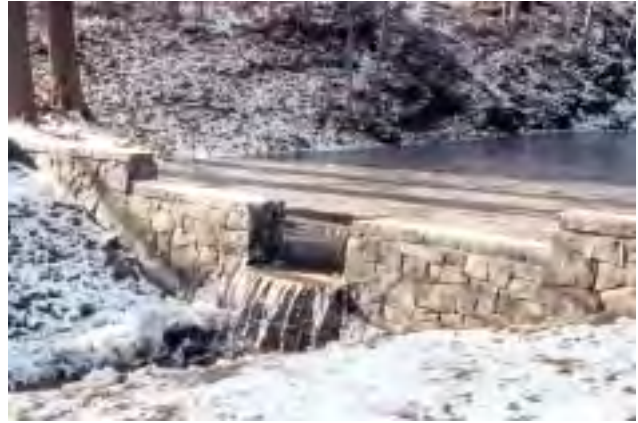
The principal spillway establishes the normal water level of the pond or lake. The function of the principal spillway is to allow normal flow to pass the dam in a safe and non-erosive manner. An emergency spillway is an auxiliary spillway designed to pass flood flows greater than the principal spillway's capacity in order to prevent the dam from overtopping during extreme storms. Spillways must be resistant to erosion because their failure may be as significant as an embankment failure and may well lead to dam failure. Because flows in spillways may reach high velocities, a stilling basin or plunge pool is often used to prevent erosion.

Spillway

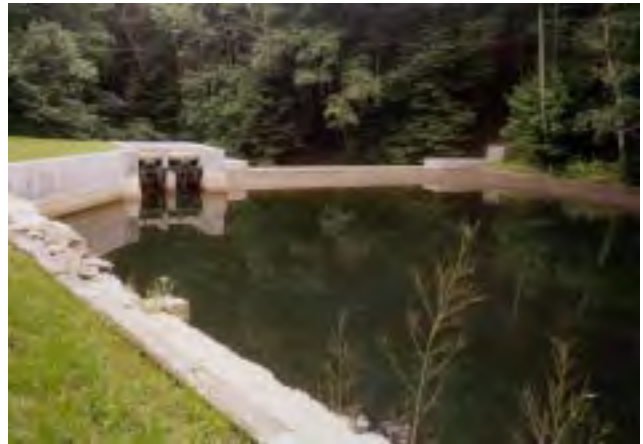
Also referred to as drawdown facilities, these structures help control impoundment levels and drain a reservoir for normal maintenance or emergency purposes. Most drawdown facilities consist of a pipe through the dam with a valve which may be operated as needed. The dam spillway and drawdown structures may be built in close proximity to one another, and an outlet structure may be incorporated into the principal spillway structure.

Intake Structure

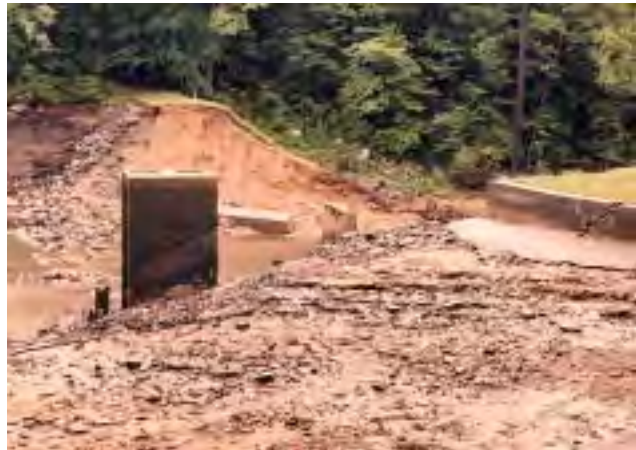
Overtopping failures result from the erosive action of the uncontrolled flow of water over, around or adjacent to the dam. Earth embankments are not designed to be overtopped and therefore are particularly susceptible to erosion. Surface erosion may reduce the embankment cross-section, saturate an earth embankment and lead to a structural failure. General causes of overtopping include inadequate spillway size and/or spillway blockage by debris.

Dam Failure

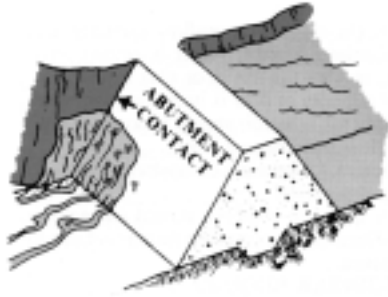
**Seepage Water Exiting at
Abutment Contact**

Can lead to erosion of embankment materials and failure of the dam.

Study leakage area to determine quantity of flow and extent of saturation. Stake out the saturated area and monitor for growth or shrinkage. Inspect frequently for slides. Water level in the impoundment may be lowered to increase embankment safety. A **QUALIFIED ENGINEER** should inspect the conditions and recommend further actions to be taken.

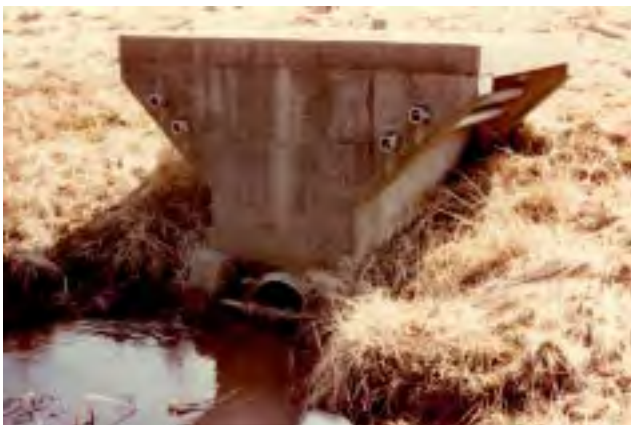
- a. Trashrack - after every major storm
 - Remove accumulated debris
 - Repair rusted or broken sections as needed
- b. Mechanical - once per year
 - Cycle (open and close) outlet gate valves through full operating range
 - Lubricate mechanisms per manufacturer's recommendation
 - Paint or grease ferrous metal surfaces as needed
 - Align stem guides or brackets
- c. Internal Conduit - once per year
 - Check for undermining or seepage around the outlet end
 - Check for corrosion or other deterioration of conduit material
 - Should deficiencies be detected, obtain immediate professional guidance before attempting repairs
- d. Concrete Features - once per year
 - Check for misalignment, cracks, spalls, scaling, exposed steel rebar, rust stains
 - Consult with DEP Dam Safety Personnel or a consultant engineer before attempting repairs

Concrete Intake Structure

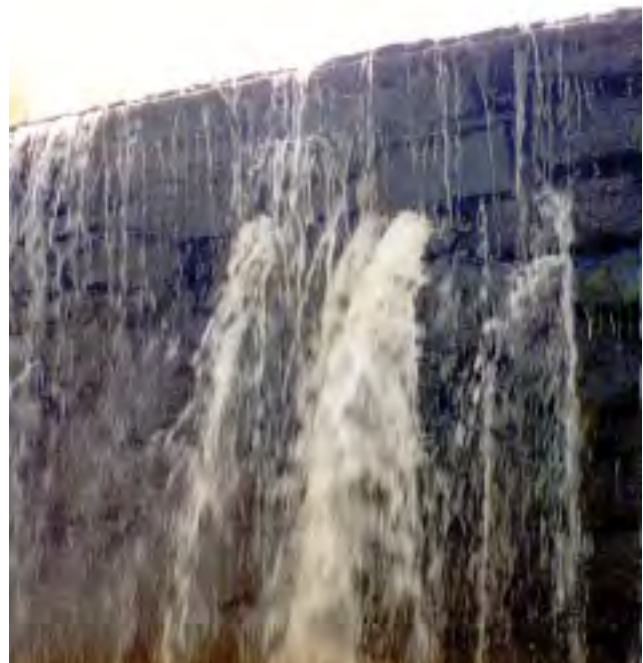
- a. Vegetation Control - twice per year
 - Remove woody vegetation within 25 feet of masonry dam structures
 - Cut trees growing in masonry walls flush with face of masonry
- b. Missing Stones - as required
 - Replace missing or misaligned capstones in spillway
 - Replace missing stone masonry in downstream and upstream walls
 - Do not mortar up or seal off the spaces or openings between the stones on the downstream face of masonry or rubble walls without first consulting a qualified engineer

Leak in Masonry Wall

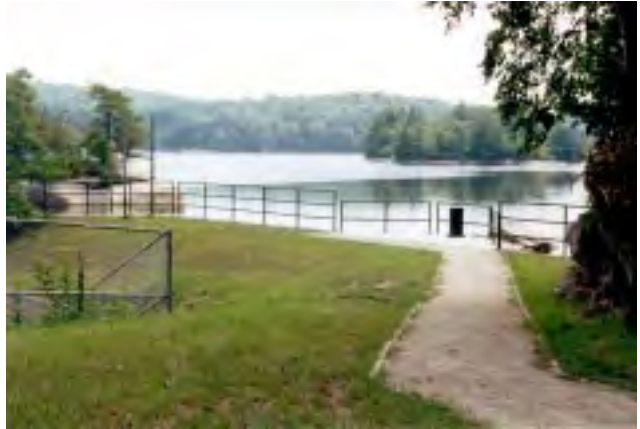
- a. Maintain vehicular and pedestrian access features to allow future inspection and maintenance - once per year.
- b. Check fences, locks and signs for damage - once per year.

Walkway, Hand Railing

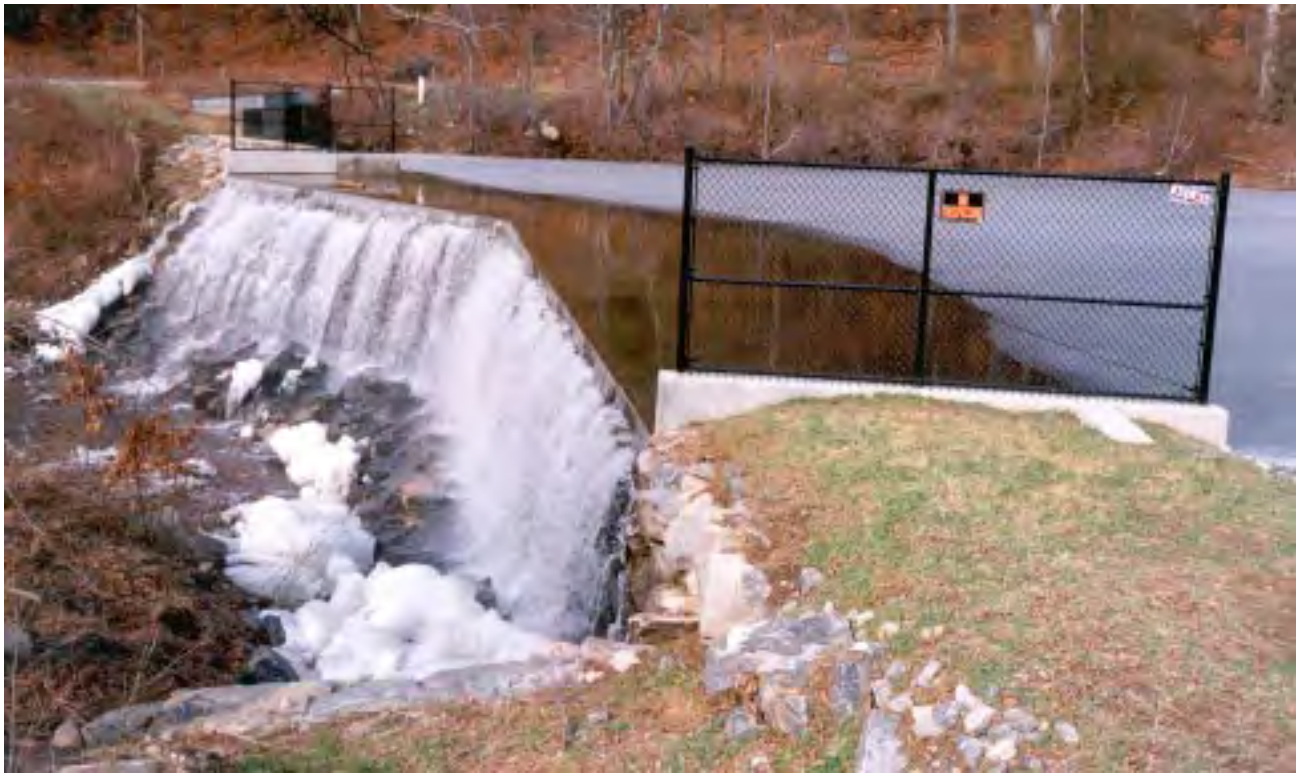
Fence and Signage

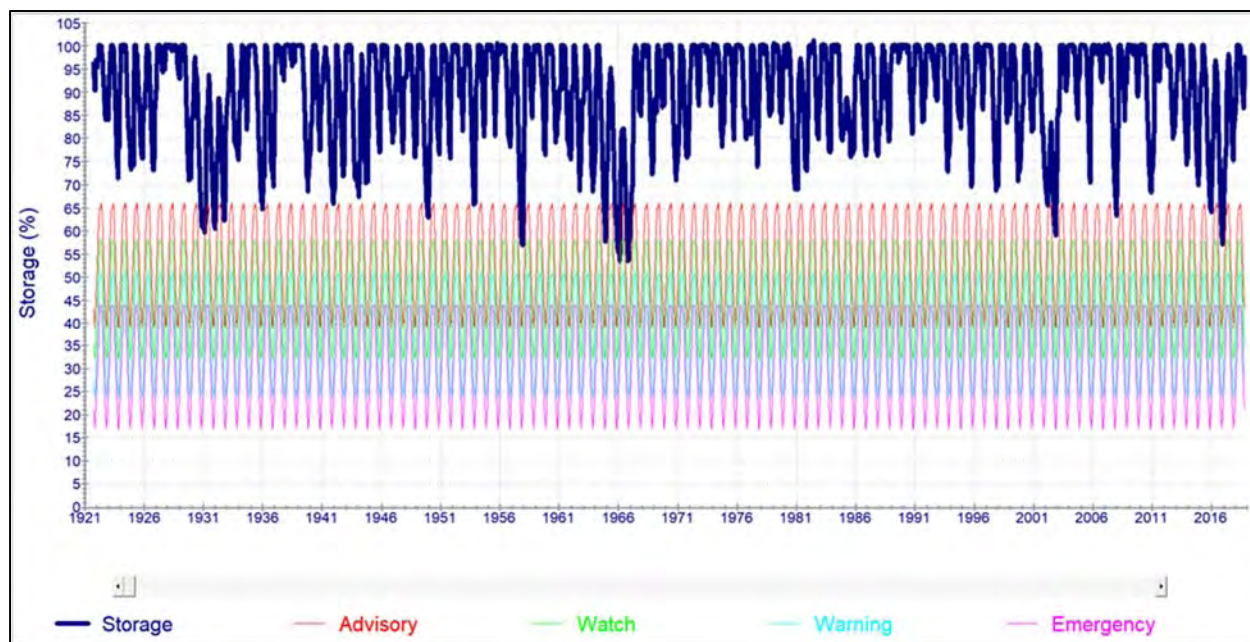
Figure 4 presents the modelled total reservoir storage over the period of available records utilizing current demands and operations and reservoir releases in compliance with the new DEEP Stream Flow Regulations.

Figure 4 - Reservoir Drawdown With New Stream Flow Regulation Releases

The minimum storage that RWA’s reservoir system would have reached over the almost 100 years modeled under current demands and operations would have been 54%, in 1966. In addition, the model simulated no occurrences of any drought stages over this time period. This analysis indicates that the RWA’s reservoir system, when fully utilized, will remain at low risk for significant drought impact after implementation of the Stream Flow Regulation release requirements.

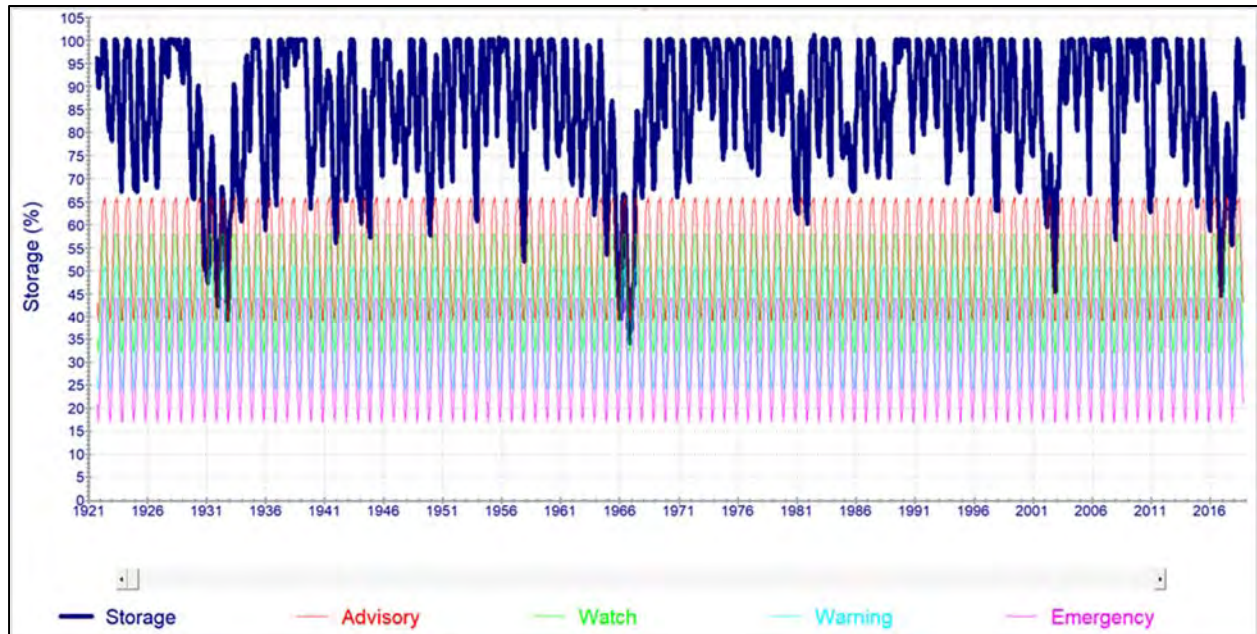
Figures 5 and 6 illustrate the impact of not using Lake Whitney on total reservoir storage under current demands as modeled from 1921 through 2017.

Figure 5 Reservoir Drawdown Under Current Conditions and w/o Lake Whitney

The minimum system storage without Lake Whitney would have been 34% under current release requirements and 24% under future Stream Flow Regulation release requirements, both in 1966. Minimum storage in the North Branford Reservoir System, which would need to increase production to offset the lost production from Lake Whitney, would have been 22% under current releases and 6% under future releases. In addition, without Lake Whitney the model predicts that RWA's system would have experienced five Drought Advisories, three of which would have become Drought Watches, over the nearly 100 years simulated under current demands and release requirements. With the future Streamflow Regulations release requirements this drought frequency would have increased to six Drought Advisories, four of which extend through Watch, Warning and into Emergency, over the period simulated.
